Power Supply Reliability Improvements

ASD Power Systems Group

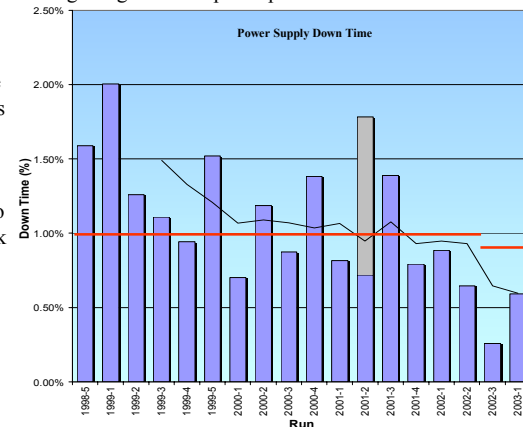
The chart below shows that we have consistently met our down time budget of 0.9% (changed from 1% in FY2003) since the beginning of FY2002 and the trend line shows the improvements over the past year.

Of course, a single major failure can still cause a great deal of down time as shown on the chart to the right. The portion of down time for run 2001-2 indicated in gray was due to a single event – a water leak developed in a booster extraction septum power supply. The problem went unnoticed long enough for the water to leak through a penetration into the tunnel and caused damage to the magnet. This event alone resulted in 13.2 hours of down time.

We have a program in place to train and certify control room operators to replace failed power converters in the storage ring. This helps keep MTTR for these common failures to a minimum.

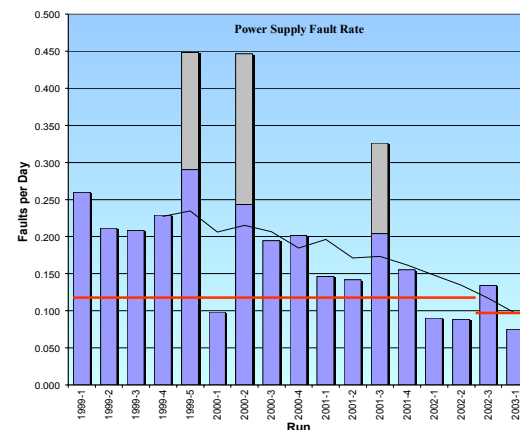
At the beginning of run 2002-3, our fault rate goal was changed from 0.12 faults per day to 0.1 faults per day corresponding to a MTBF of 240 hours.

The chart to the left indicates that we have had some success in recent runs, however we are not yet consistently meeting our goal, so there is room for improvement. Our

Outliers, indicated in gray on the chart, are the result of the following:

- Run 1999-5: Glitching power supply that was difficult to identify.
- Run 2000-2: Software limit removed inadvertently.
- Run 2001-3: Incorrect diagnosis in conjunction with reset policy at the time.

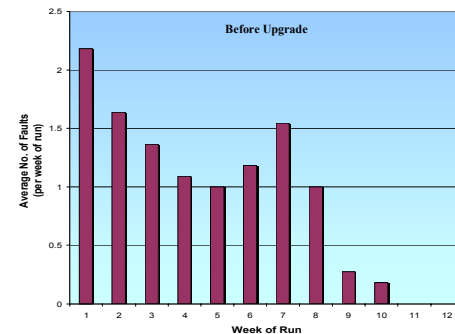
The control power upgrade is a perfect example of how we have put our fault analysis to good use. The chart to the left indicates that we used to see a large percentage of our faults in the weeks immediately following a shutdown. The majority of these faults were failures in the control power assemblies and related circuits after being powered off during the shutdown.

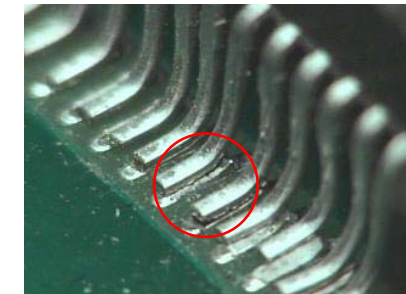
There are probably upwards of a billion solder connections in the power supplies and supporting electronics that make up the APS storage ring. Interestingly, a defective solder connection can work fine for years and suddenly begin to fail intermittently making it extremely difficult to troubleshoot.

As part of our quality control program, we have recently adopted the industry accepted IPC-A-610C standard for Acceptability of Electronic Assemblies. Our entire group has been trained and certified by IPC to inspect electronic assemblies to this standard. Not only do we require this level of workmanship for in-house work, but outside vendors are required to meet this standard as well.
