# Linac RF Commissioning with the SNS HPRF Systems

4<sup>th</sup> CWHAP Workshop

**May 3, 2006**

SNS RF Group

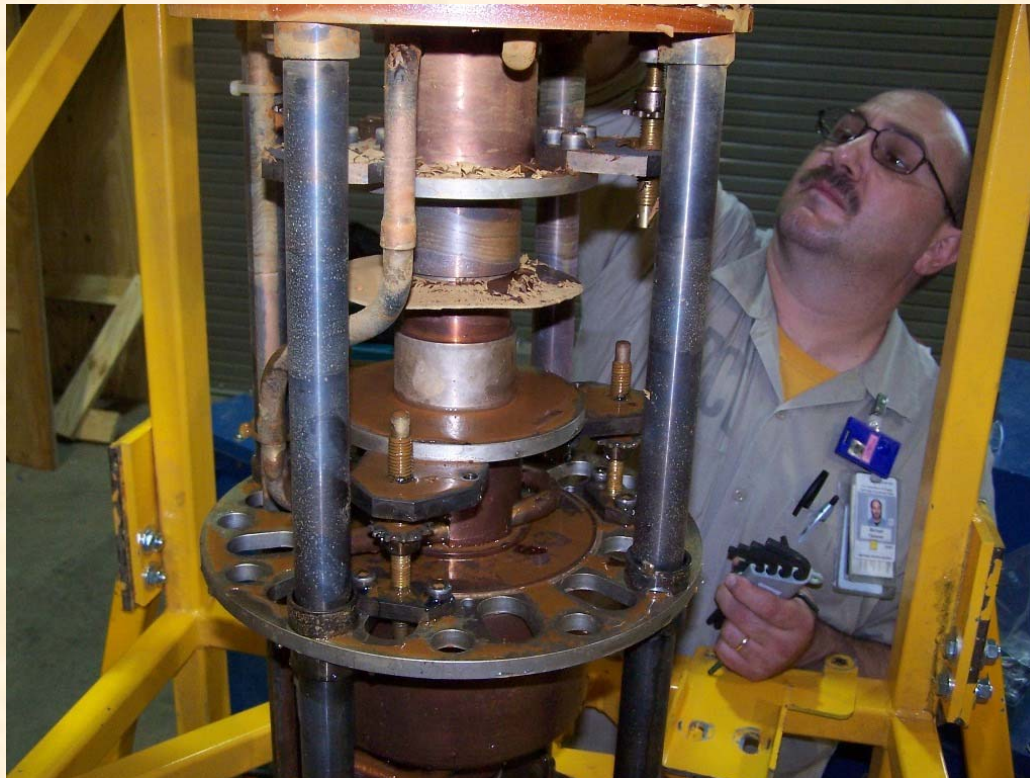
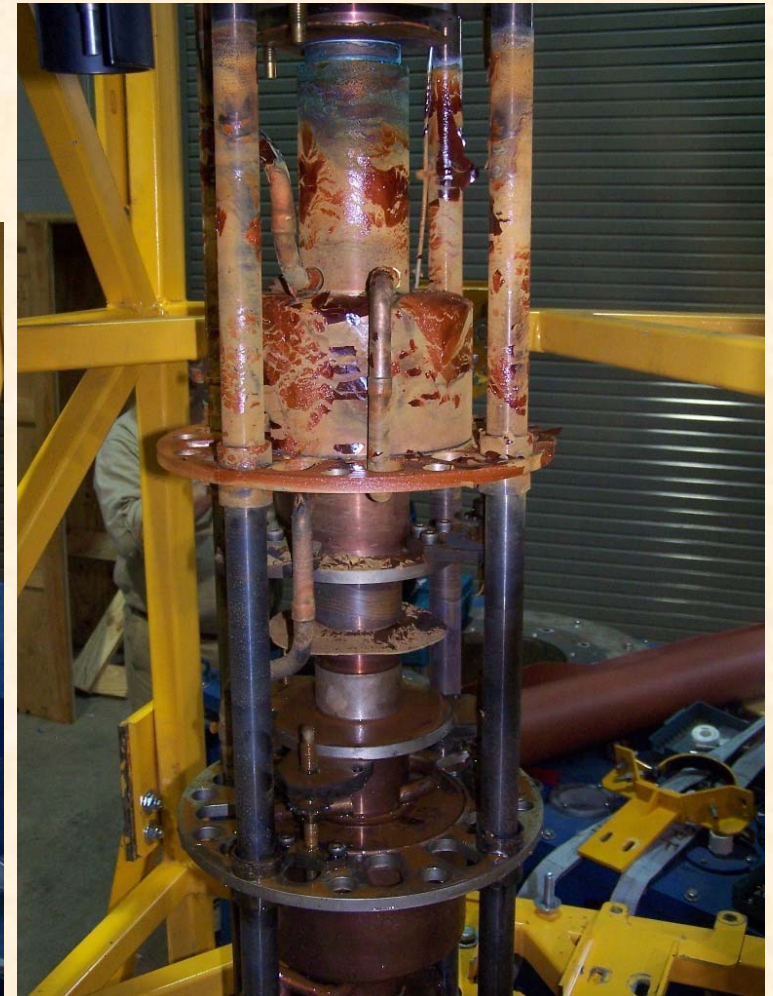
# Source of Low Power Output Discovered in TH-2177 (805 MHz, 550kW klystron)

magnet water leak filled up the magnet cylinder with water.

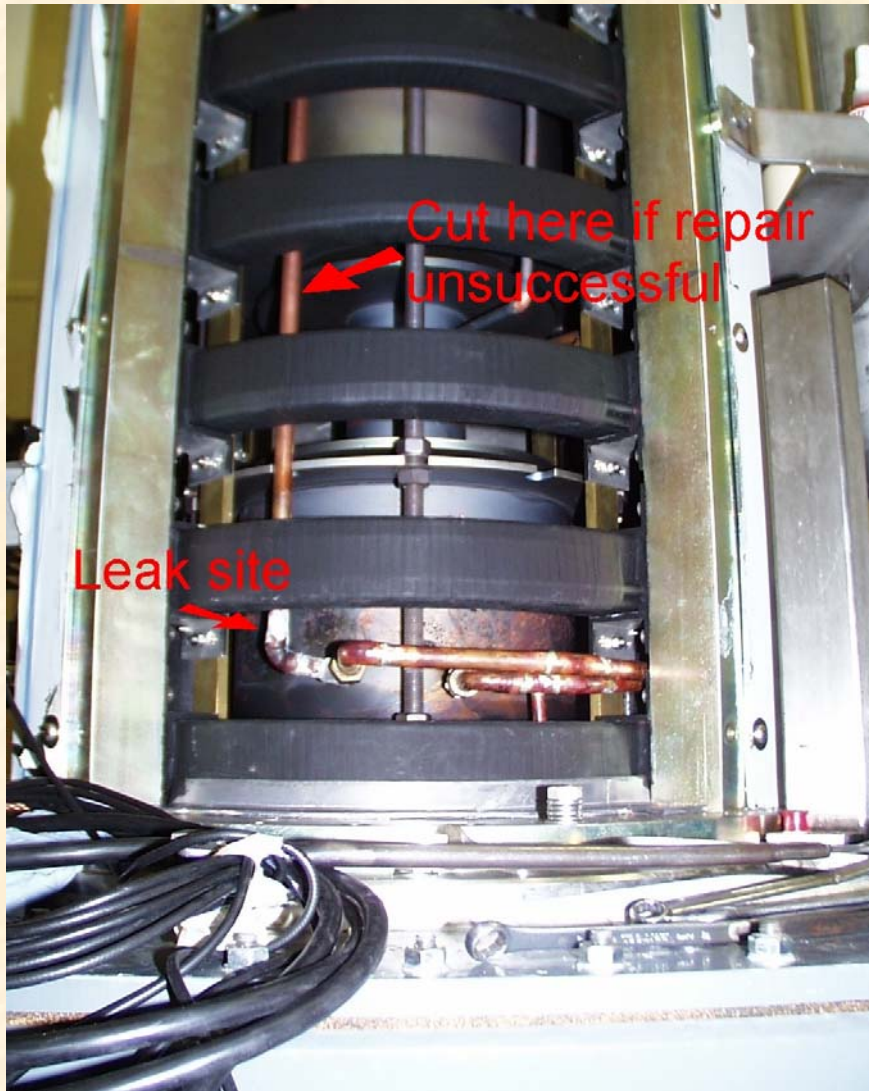
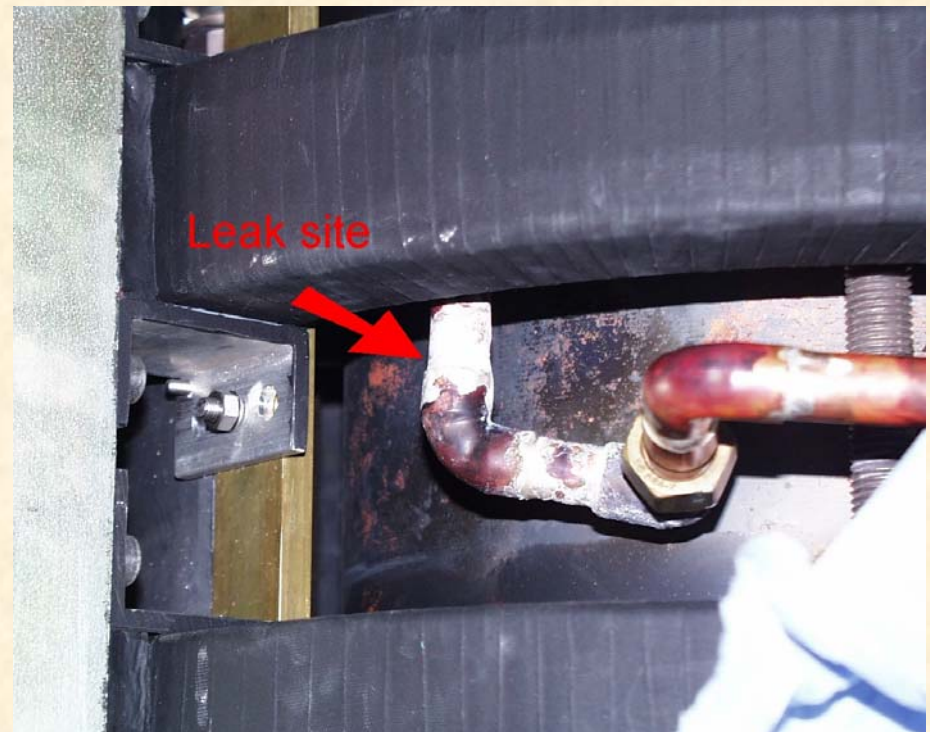
## Klystron Internal Water Leak (into HV Tank)

Early production units had QA problem with water fittings.

High temperature brazing is potentially damaging to solenoid coils.

Replace section of body water circuit  
in-situ

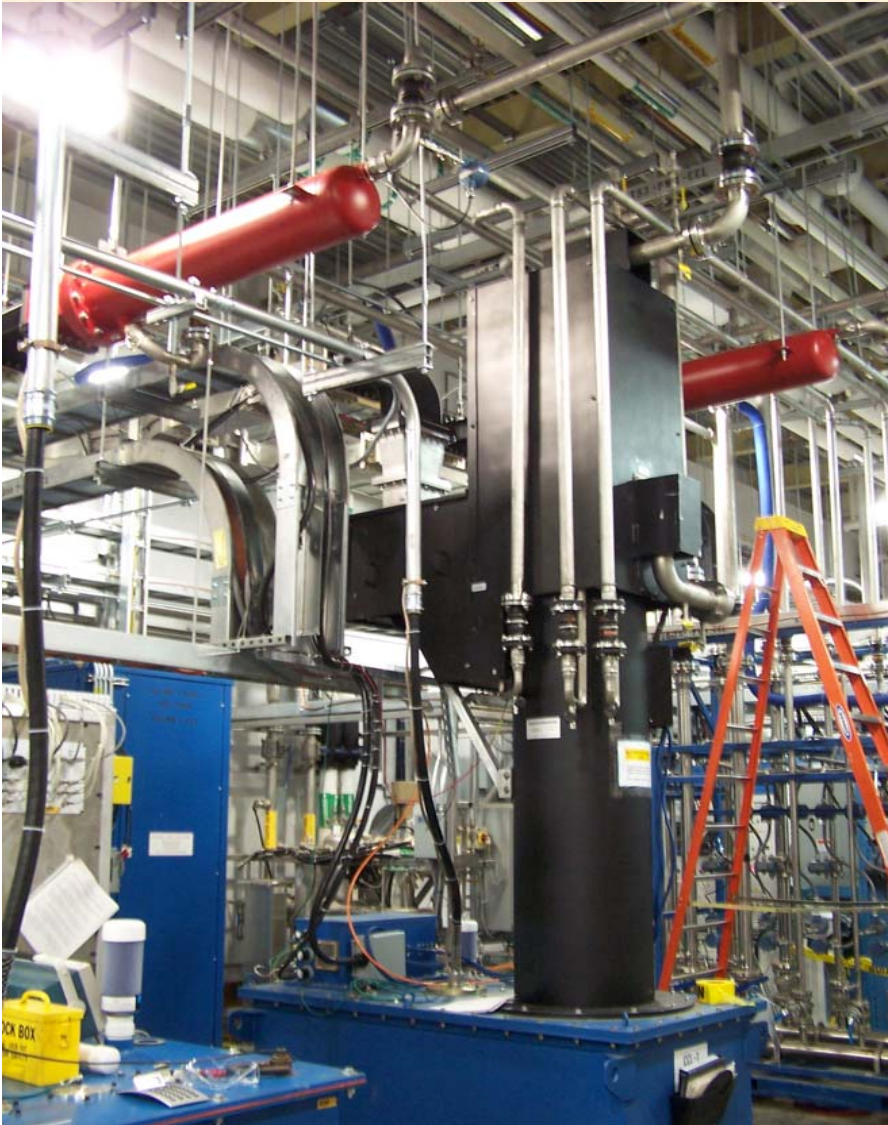
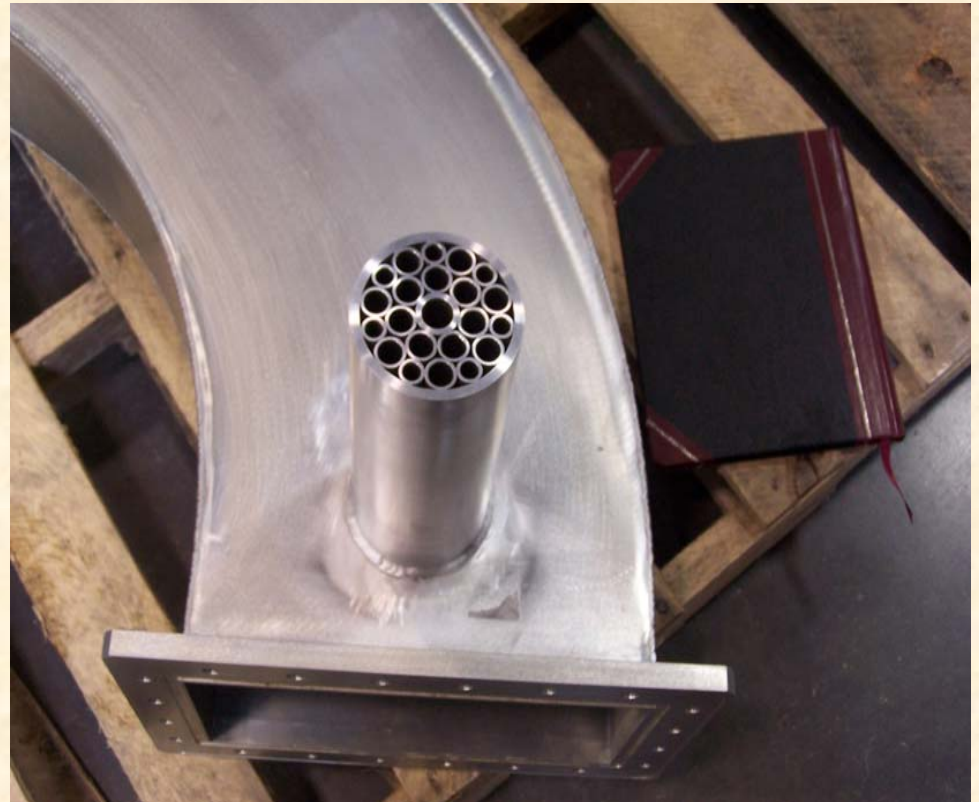
# Modification to Air Cool CCLWaveguides

5 MW klystron will heat the waveguide and increase the chance of arcing. The un-used blower from the 2.5 MW tubes was put to use here.

Added SF6 to output and circulator.  
Air-cooled waveguide.

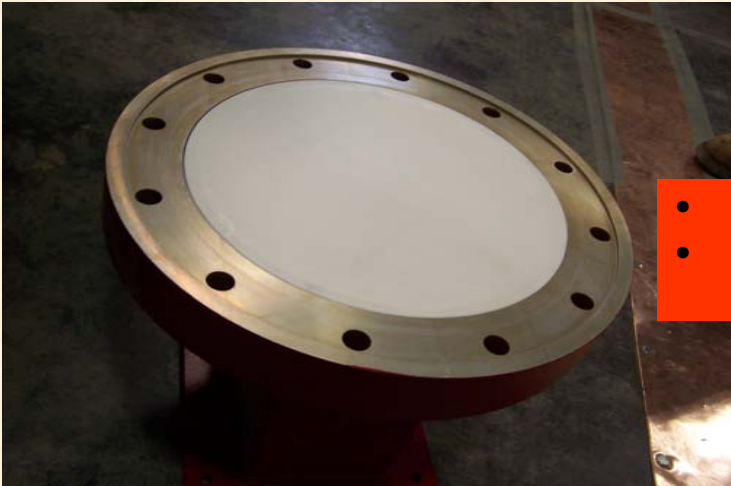
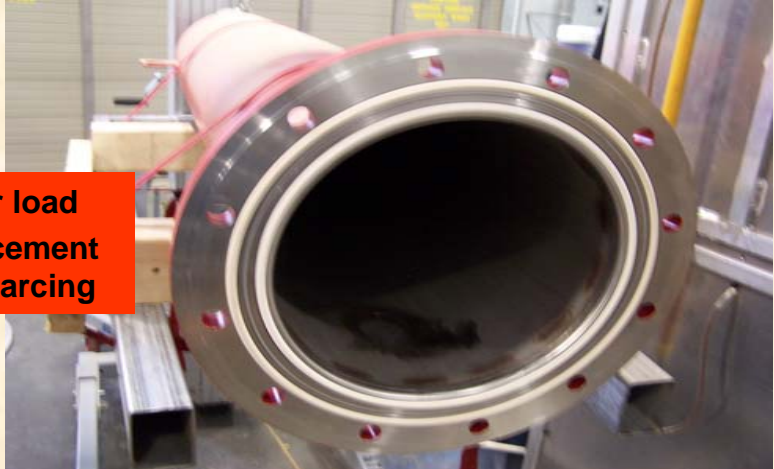
Arcing at window

- 5MW water load
- Seal replacement to prevent arcing

Replaced seals with different  
material.

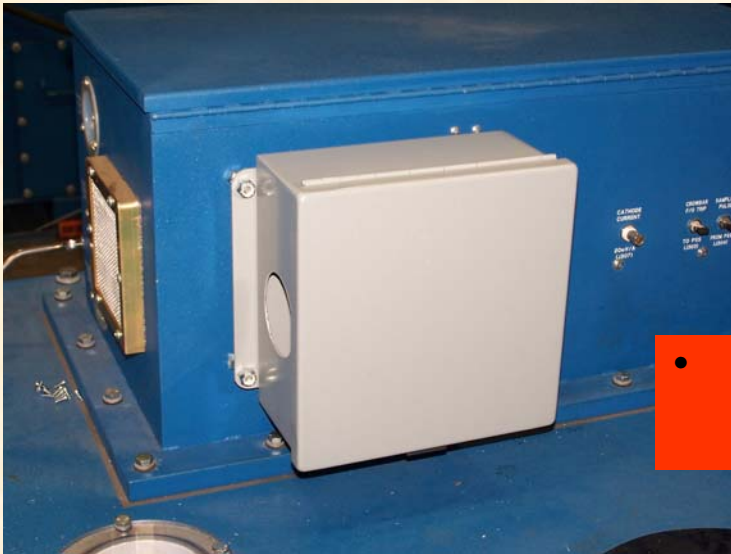
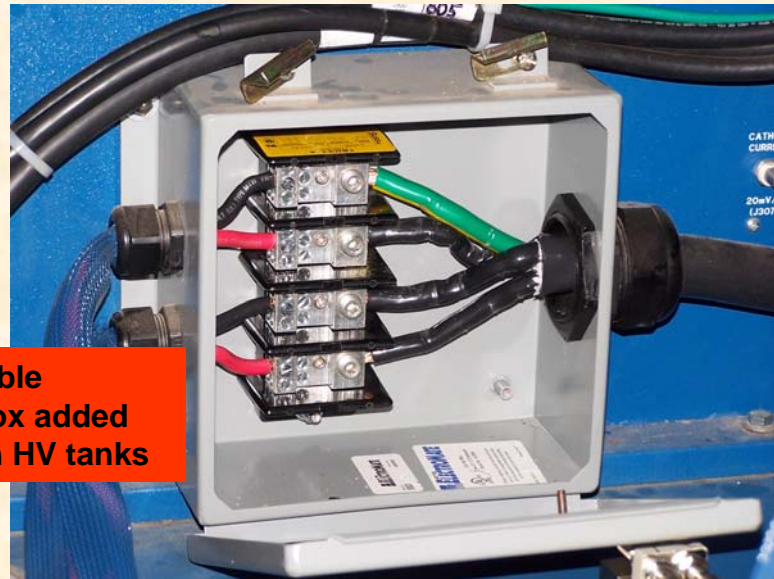
- Magnet Cable junction box added to Klystron HV tanks

Junction box facilitates quick disconnect to klystron and allows measurement of magnet current and voltage.

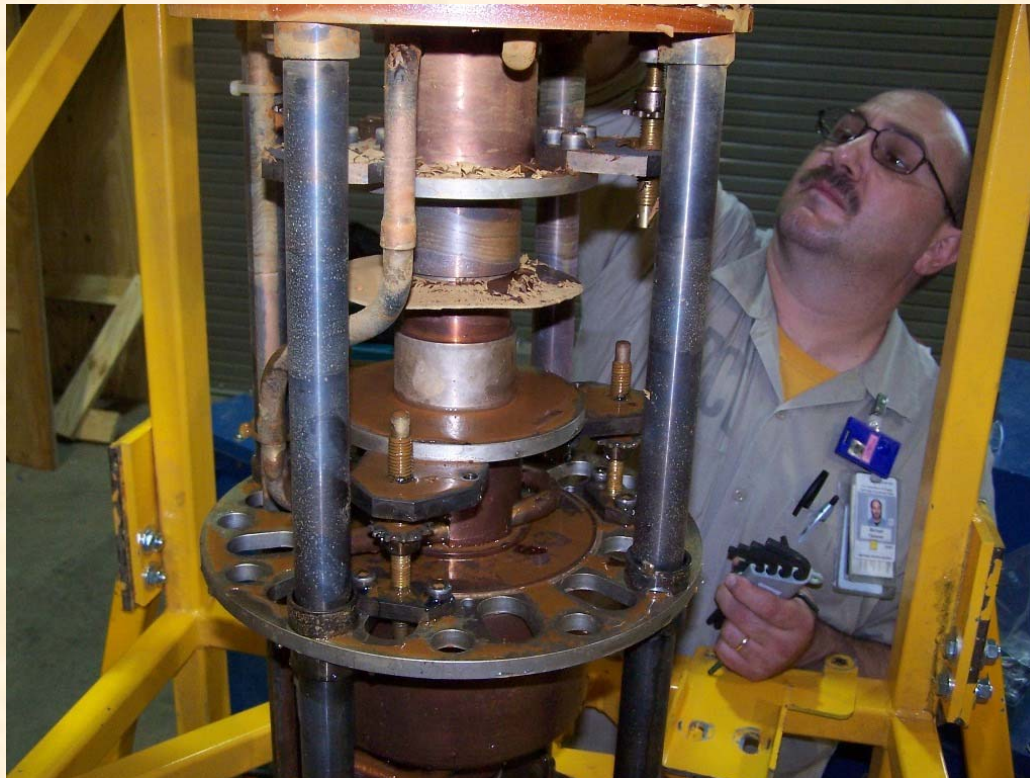
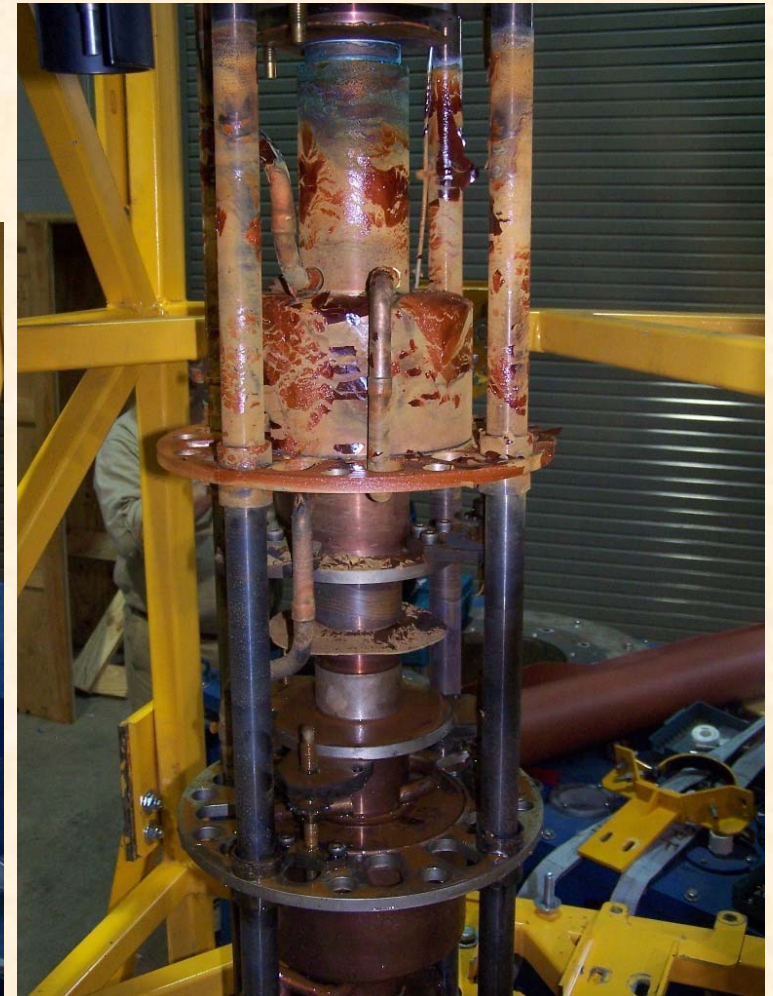
# Source of Low Power Output Discovered in TH-2177 (805 MHz, 550kW klystron)

magnet water leak filled up the magnet cylinder with water.

Returned to the factory for repair.

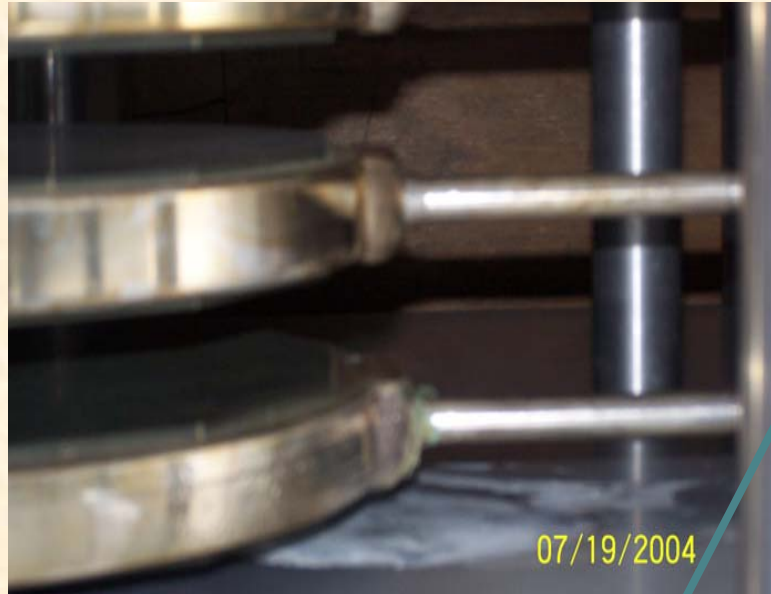
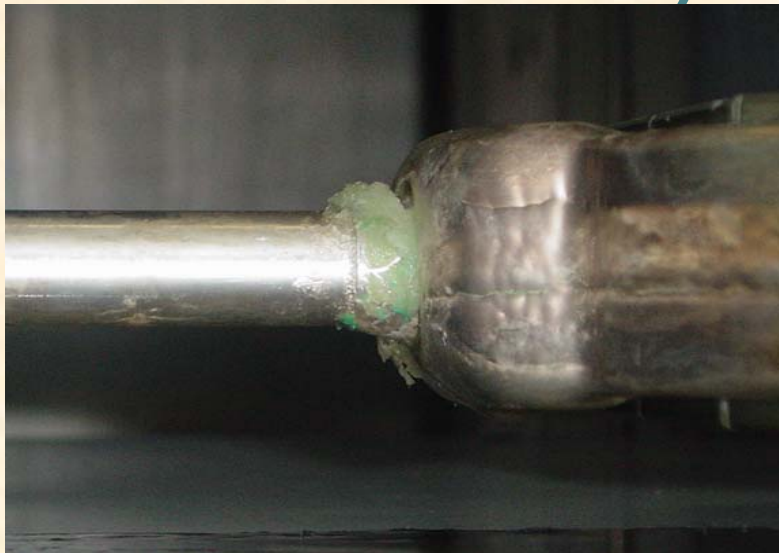
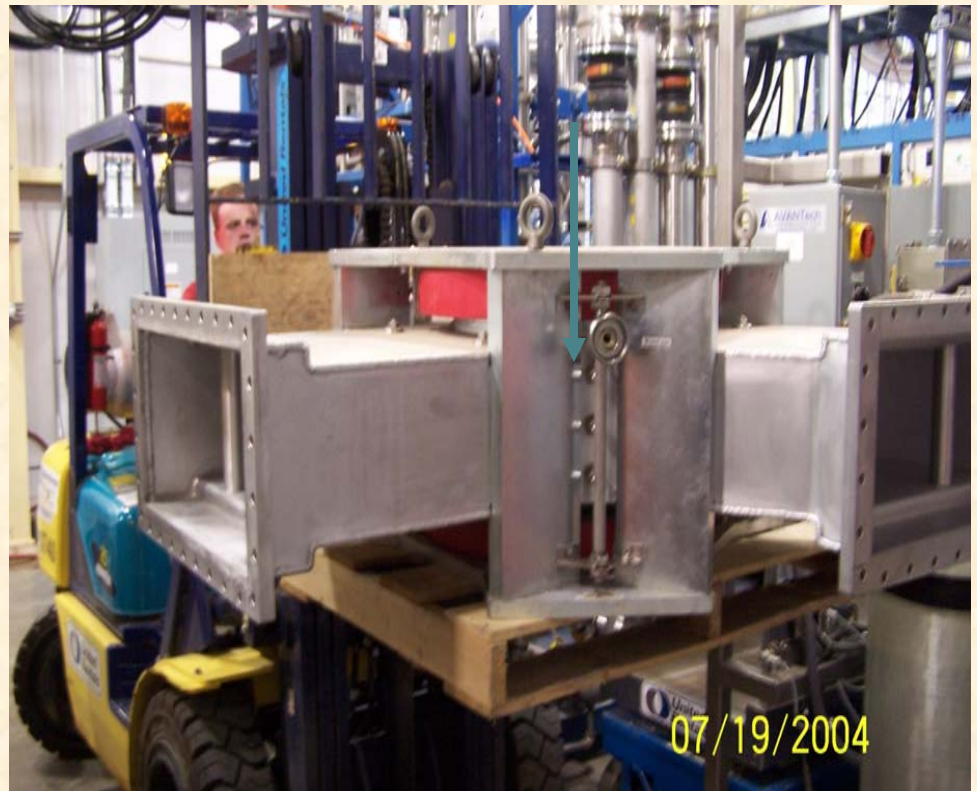
# Leaky Circulator - DTL5

Slow accumulative internal water leak

Water leak at internal joint

Replaced circulator (factory  
warranty), installed water drains  
in connecting waveguides.

Replacement coming in.

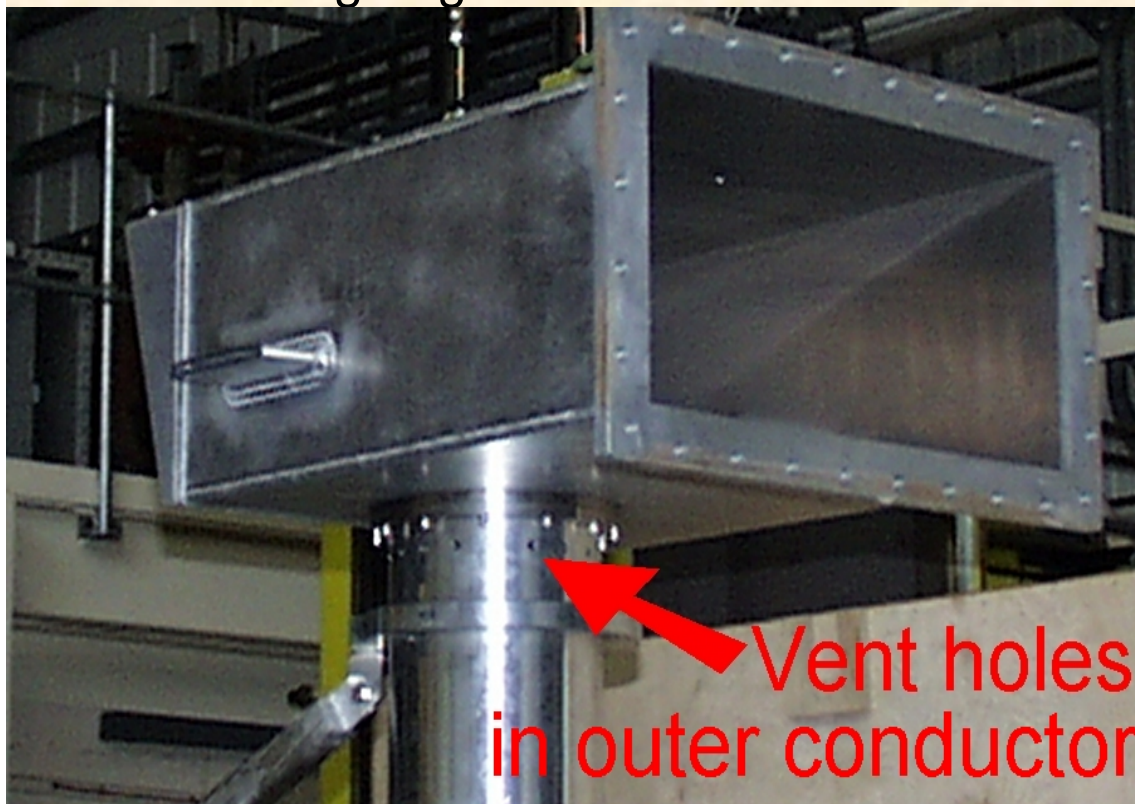
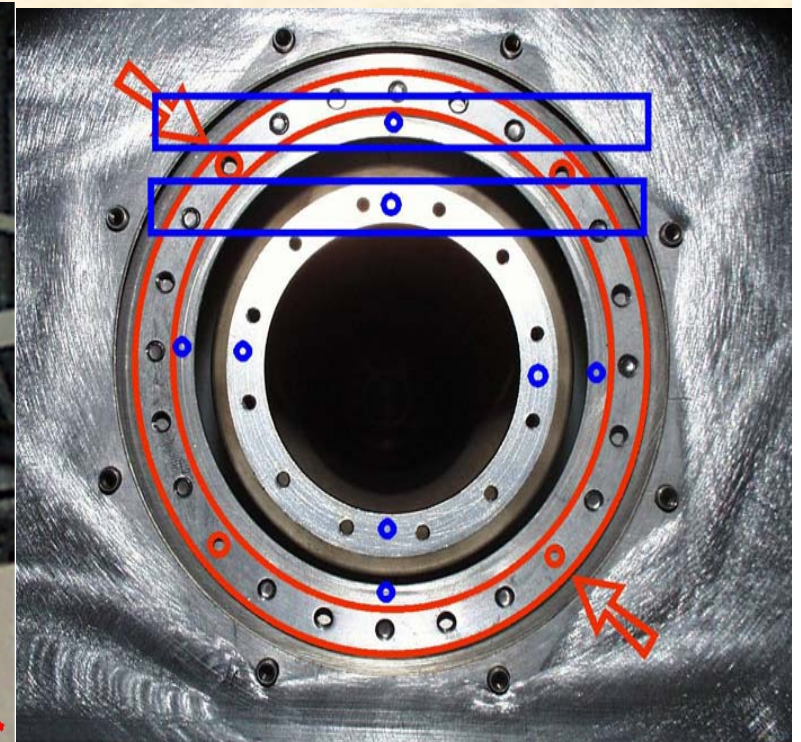
# Broken 2.5 MW Klystron Output Coax-to-WG Connection

Symptoms: Arcing seen in air vents at coax to waveguide interface when power exceeded 350 kW peak.

Problem: Inner and outer coax unequal in length causing stress on connecting ring.

2.5 MW Klystron Output Coax to Waveguide Connection. Gold Ring Connects Inner to Outer Conductor.

Factory design error. Installed  
spacer disk to equalize length of  
inner and outer coax  
conductors.

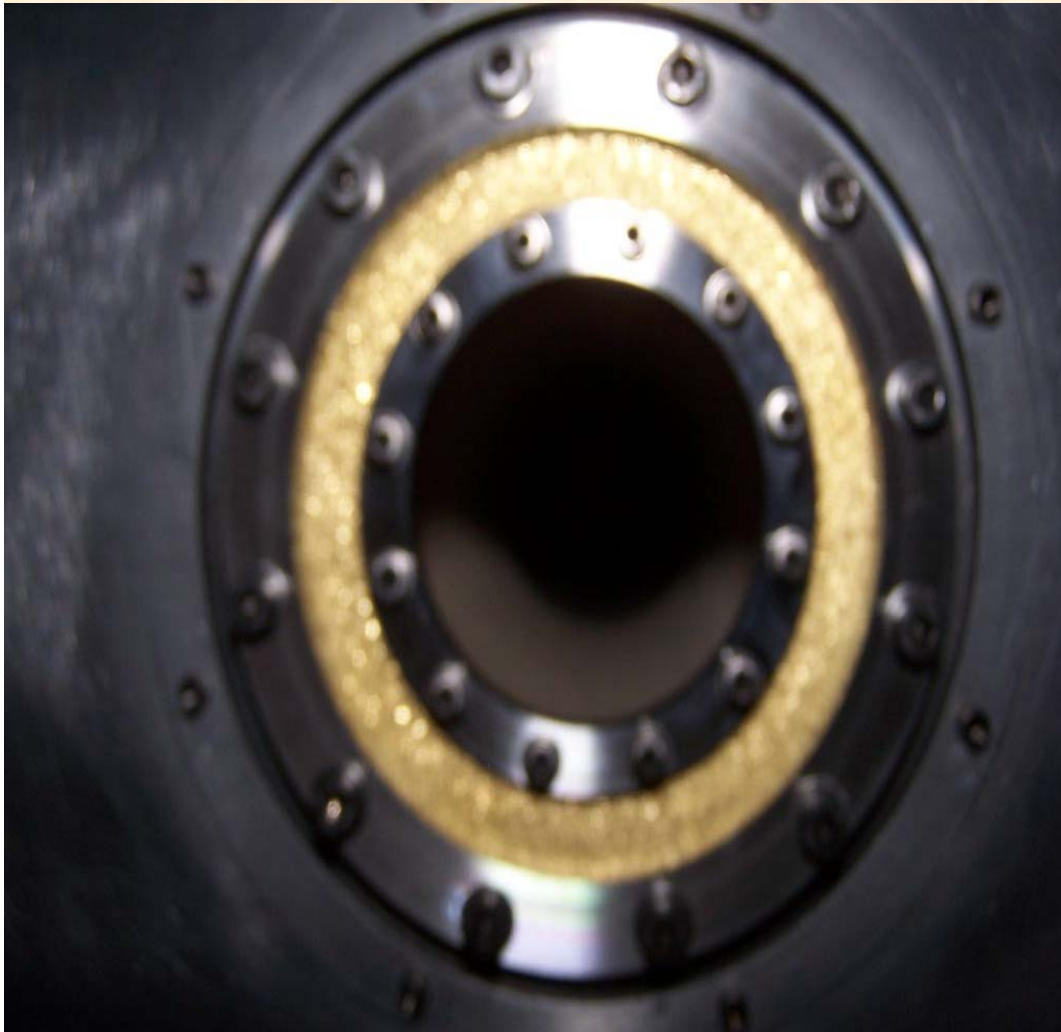
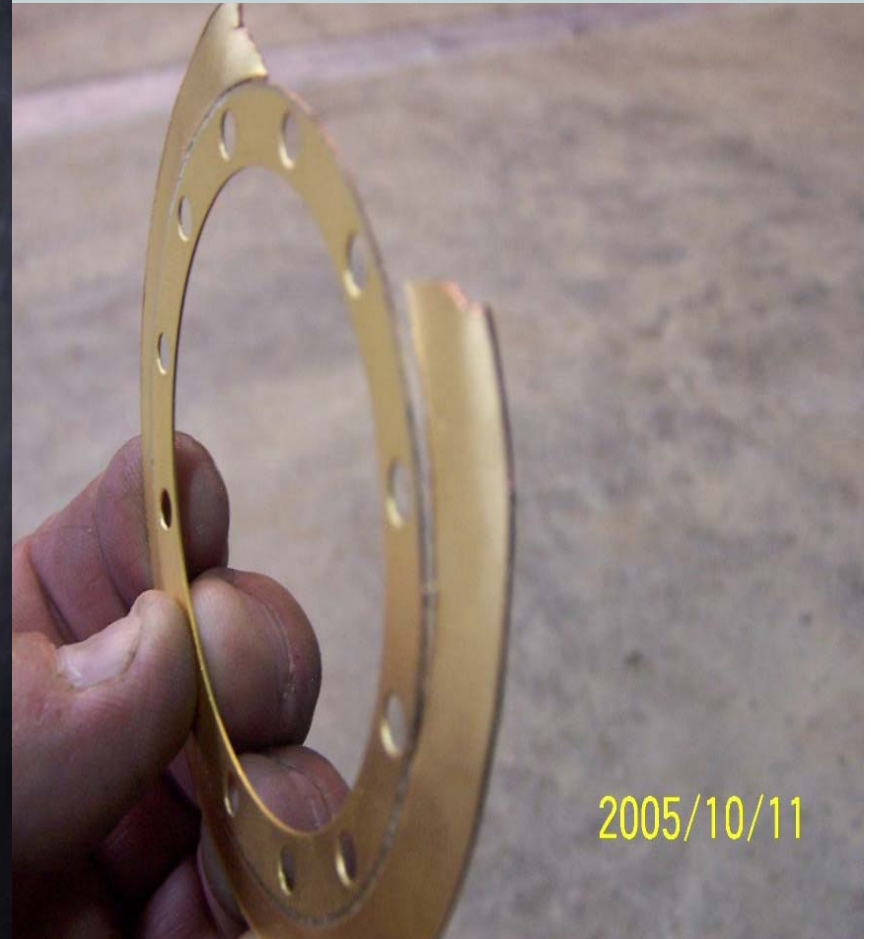
Inner Conductor 1-2 mm longer than Outer Conductor. Resulting Stress Fracture.

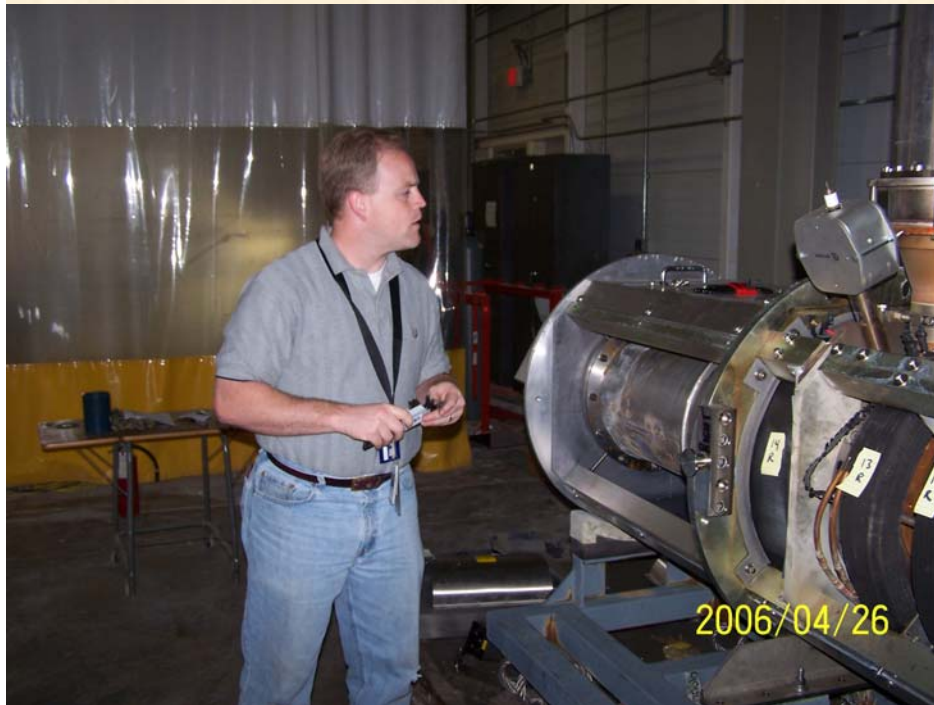
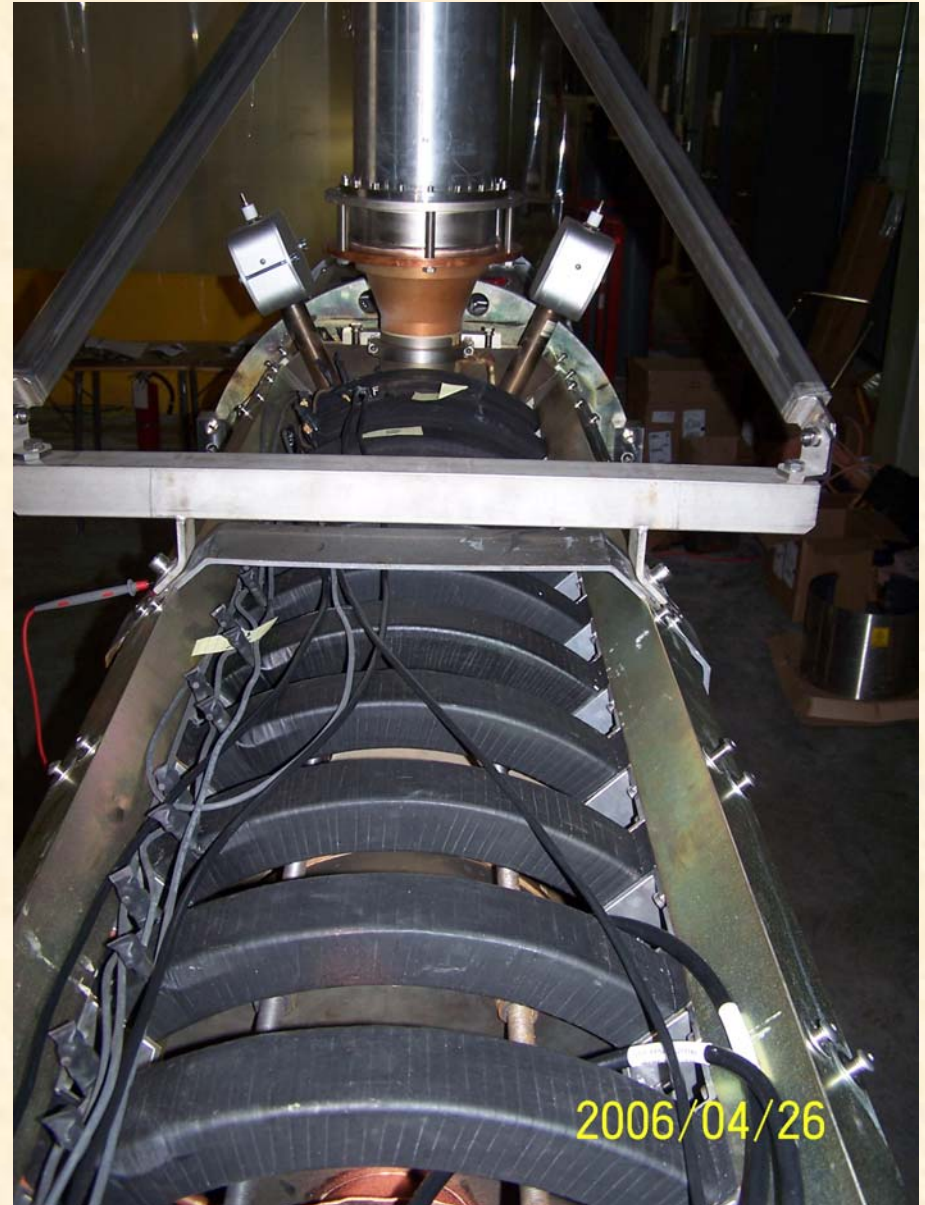
DTL-3 2.5 MW Klystron with shorted magnet cables. Cables were likely shorted by water leaking into barrel connector.

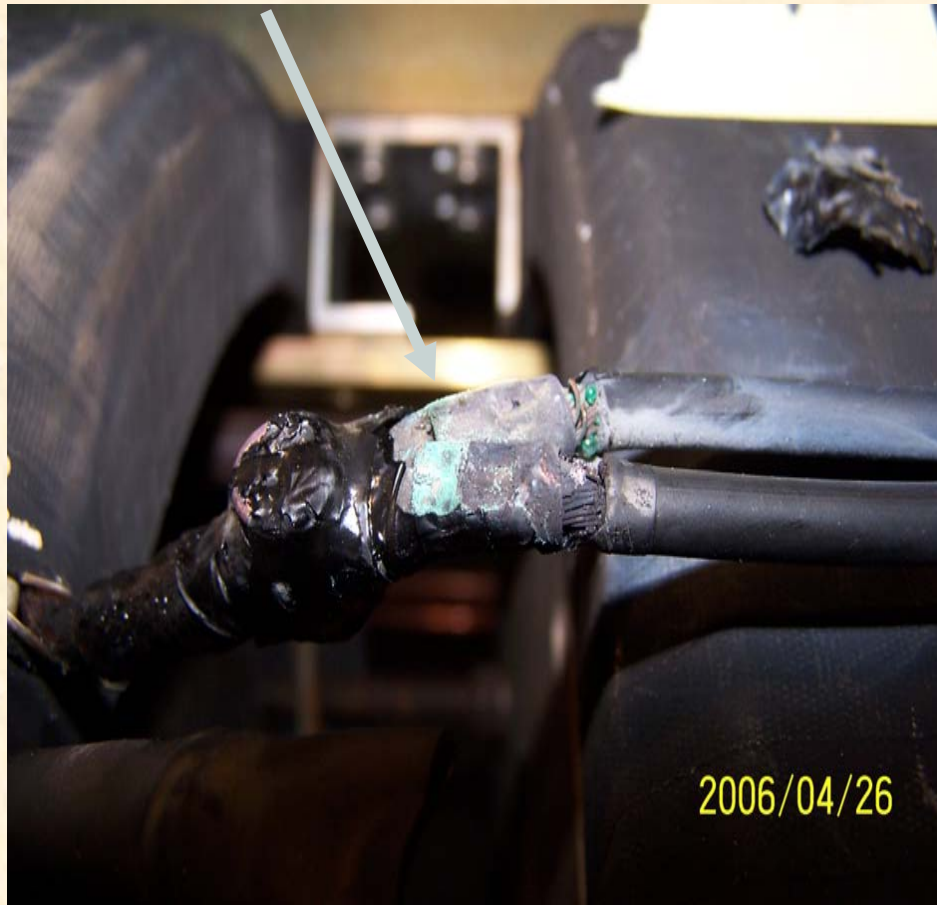
Melted Electrical Tape and Corroded Magnet Connections

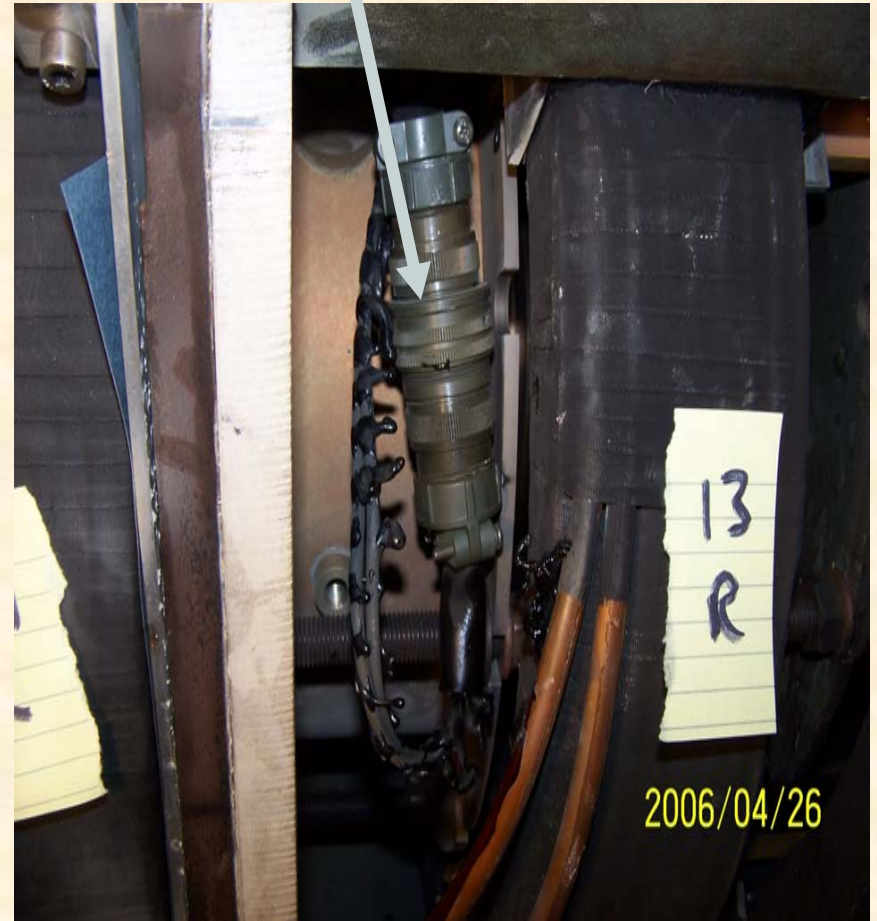
Short May Have Started By Water Leaking into This Connector
