# SNS Klystron Developments

**Daniel Rees, Joseph Bradley, Mike Lynch, William  
Roybal, Paul Tallerico, Karen Young  
Los Alamos National Laboratory  
2006 CW RF Workshop  
May 1 – 4, 2006**

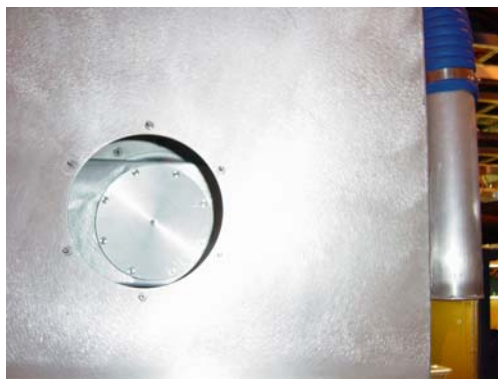
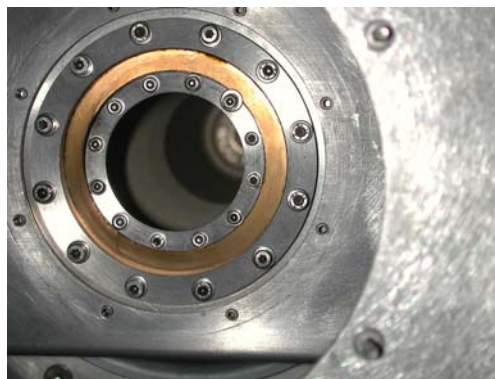
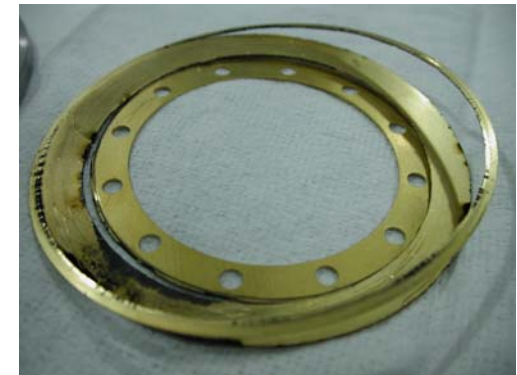
- **Issue - RF Gasket which connects coaxial output center conductor to waveguide t-bar failed during 96 hour heat run. Same gasket on other tubes showed damage.**
  - Discovered coaxial center conductor tolerance problem and lack of gasket assembly procedure (inconsistent bolt torques).
  - Implemented new assembly procedure.
  - Will use shims to address mechanical tolerance problem on delivered klystrons.
  - Proposed 2 additional gasket inspections (after 500 hrs and 1 year later)
  - Corrections to all fielded klystrons required about **5 months**

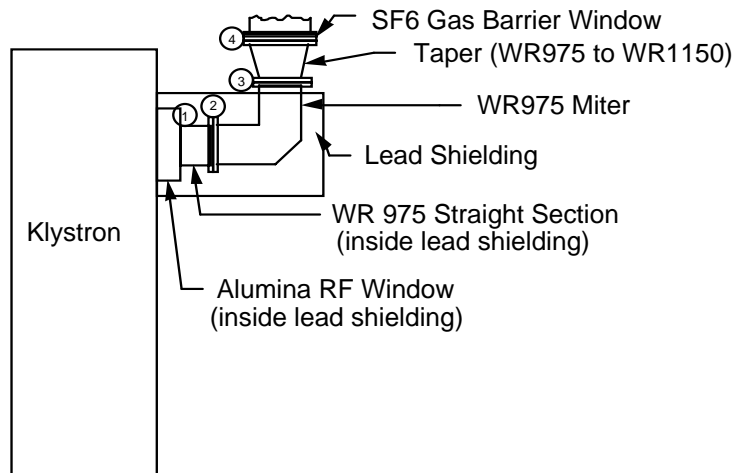
## SF6 Region in Waveguide Output Circuit

# We had to help Thales redesign the output waveguide on the 5 MW klystron.

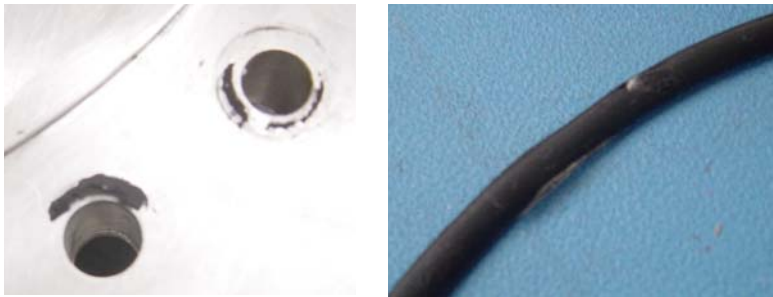
O-ring Damage near Copper Gasket that caused SF6 leaks (Joint 1):

- **Joint 1:** Arcing due to SF6 leaks and poor RF contact.

==> By helium leak checking we found SF6 leaks at this joint. O-rings were later found to be damaged.

==> Thales plans to replace all o-rings with a flat rubber gasket.

==> Thales plans to machine this piece instead of weld it because the welds limit the torque that can be applied to Joint 1 and Joint 2.

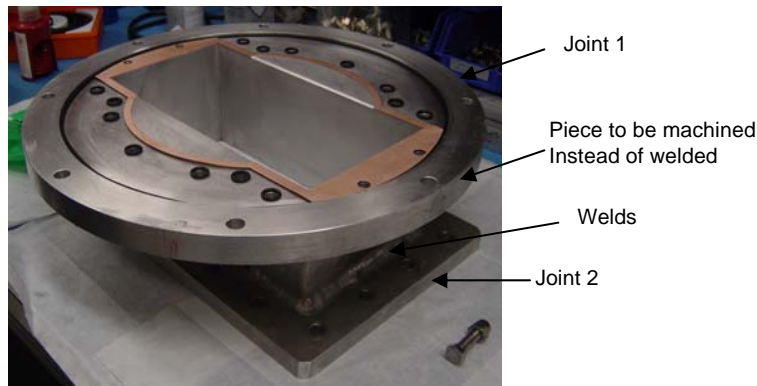
O-rings (SF6 seal) and Copper Gasket (electrical seal) before assembly (Joint 1):

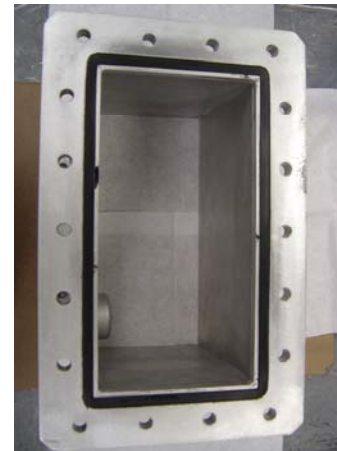
- **Joint 3:** Arcing at the joint between the taper and miter. O-ring from Mega was the wrong size. Thales made an o-ring which failed to provide a good RF contact.

O-ring between taper and miter (Joint 3)

==>we machined the flange flat to eliminate the o-ring groove. Will use a Parker seal.

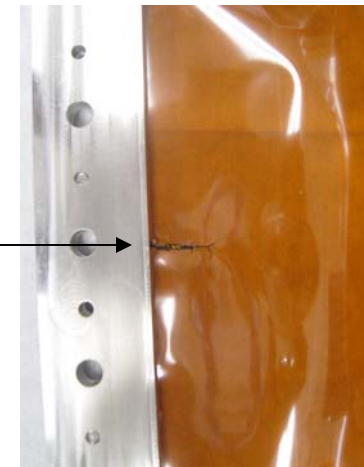
- **Joint 4:** Arcing at the Kapton window.  
==> We speculate it is arcing due to high order modes in the region of the Kapton window. We plan to move the Kapton window 16 inches farther away from the klystron.

Arc Damage on Kapton Window (Joint 4)
