ELEVATION CHANGES OF THE SPRING-8 STORAGE RING

Sakuo MATSUI, Chao ZHANG, Kazuma NAKASHIMA, Hikaru KISHIMOTO,
and Masayuki TANAKA

Spring-8, Kamigori, Ako-gun, Hyogo, 678-12, Japan

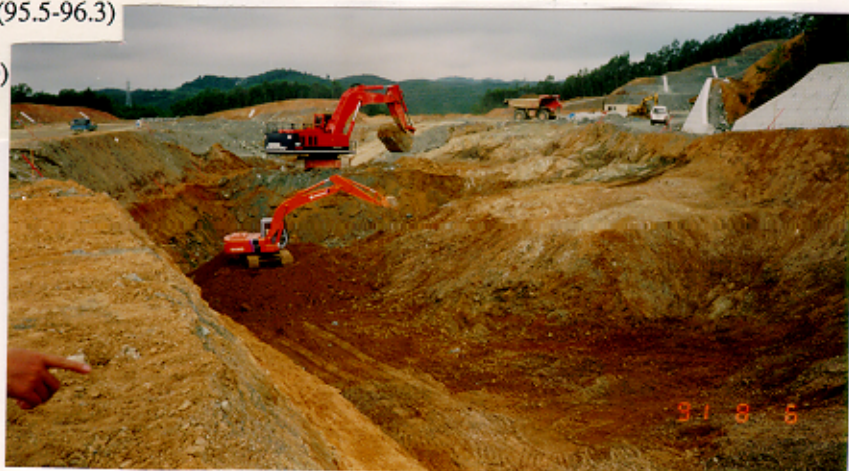
Fig. 2. Cross sectional view of the improvement.

Though the storage ring was constructed mostly on the hard rock, in some sections the ground was replaced by artificial hard rock (Fig.1). The total volume of foundation improvement including that for the linac and synchrotron areas was 70000 m³. Figure 2 shows the cross sectional view. The schedules for the tunnel construction and magnet installation are summarized in Table 1. The tunnel was constructed in four phases. After the tunnel construction, the baseplates were made into the floor. Then girders were set on these baseplates.

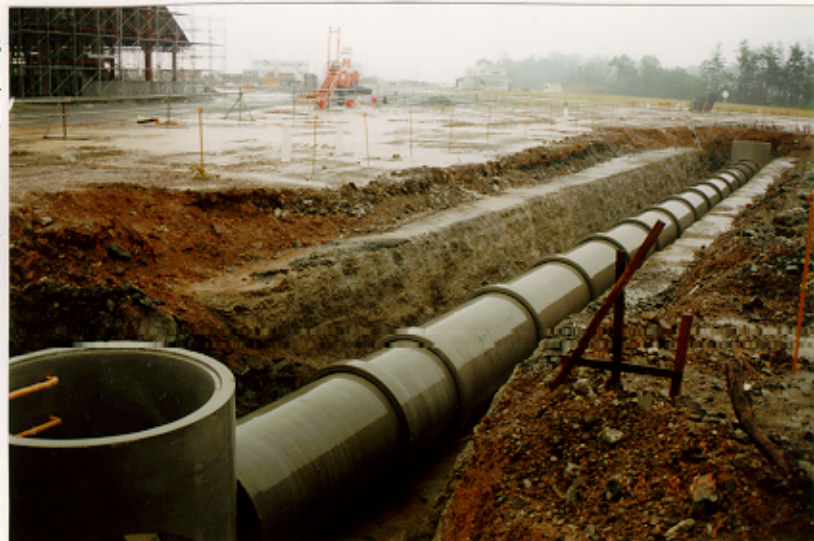
Fig. 11. Drain pipe before tunnel floor construction.

The floor levels over underground drain pipes of 0.9m diameter at five locations changed from ± 0.1 to ± 0.2 mm in the same way. Since both ends of this pipe were opened in the air (Fig.11), the floor over the pipe section was warmed and cooled. The depth from tunnel floor level to the top of the pipe is about 1.3m.
