# *The Partial Discharge Tests of the High-Voltage Cables and Other Components at the APS*

*Alex Cours, Albert Hillman  
Argonne National Laboratory  
APS/ASD*

- **Part I – The Advanced Photon Source (APS) Linac modulator cable characterization.**
- **Part II – The design and testing of HV cables for the APS particle accumulator ring (PAR) kicker magnet upgrade project.**

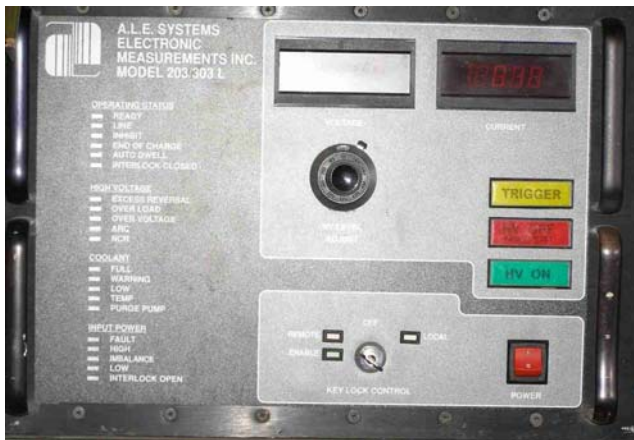
# The EMI Charging Power Supply and Connector 1

- The EMI 40-kV constant current HVPS is used to charge the modulator PFN.
- Average charging current is 0.7 - 0.8 Amps.
- One particular feature of the supply makes our life a little more difficult (will tell in a couple of minutes...).

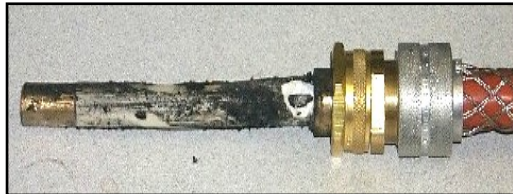
## *HV Cable Failures 1*

- **At some point amount of breakdowns in the Linac modulator HV cables (rated at that time 75 kV dc) started to grow.**
- **Type of the damages indicated that they were caused by partial discharge (PD) activity in the cable connectors.**

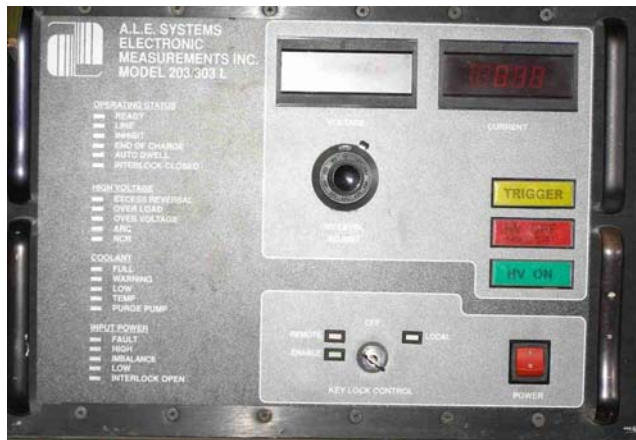
## The EMI Charging Power Supply and Connector 2

- The EMI 40-kV PS forces us to use a specific type of HV connector that cannot be replaced by another type since a part of it is located inside the densely packed PS.
- This connector is unique because of its main parts: the body, feed through, insert, etc., are commercially available from companies that produce... plumbing components.

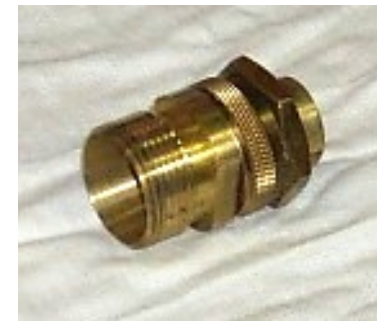
- One of the parts: the “reducer”.

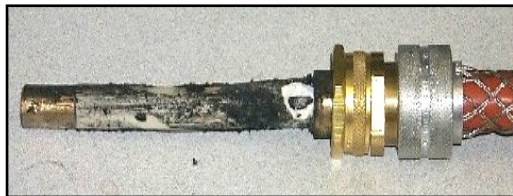
## HV Cable Failures 2

- At some point amount of breakdowns in the Linac modulator HV cables (rated at that time 75 kV dc) started to grow.
- Type of the damages indicated that they were caused by partial discharge (PD) activity in the cable connectors.
- A cable with higher operating voltage (100 kV dc) and more reliable connectors were chosen to replace the old ones.
- During the year of 2004 all old cables were replaced, and the modulators were modified in order to reduce amount of cables and eliminate voltage reversal and high frequency oscillations in the cable connectors.
- No cable failures have happened since then.

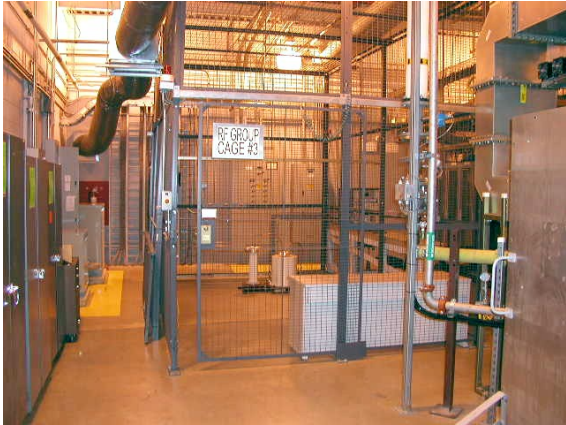
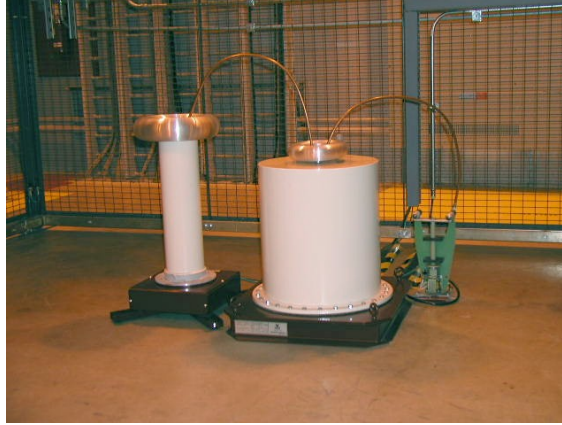
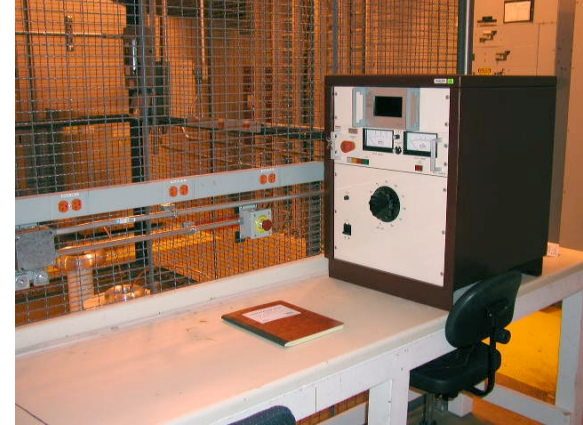
## AC Dielectric Test Set

- An AC dielectric test set (the Set) with a PD detector was installed and commissioned at the APS in January 2005.
- The Set has output rating of 40 kV ac, 75 mA.
- The Set is used on a regular basis for the following purposes:

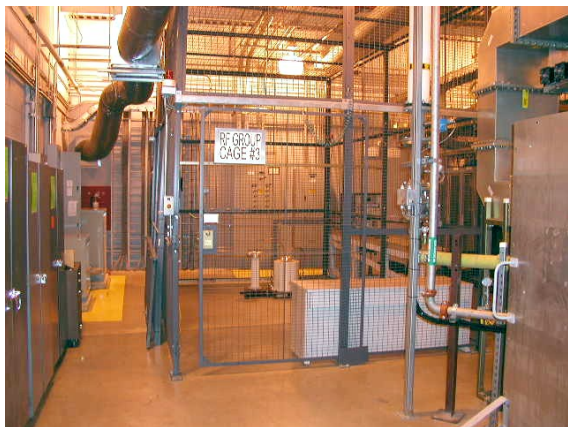
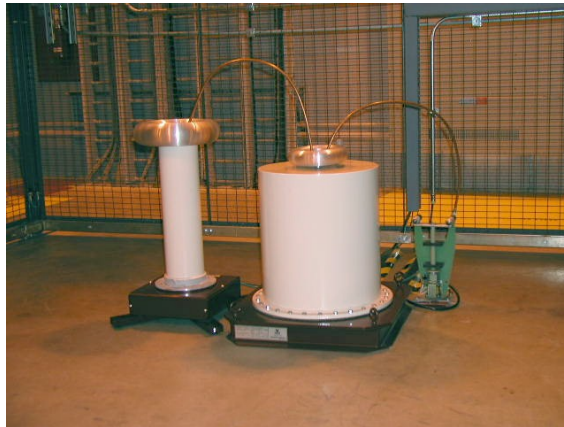
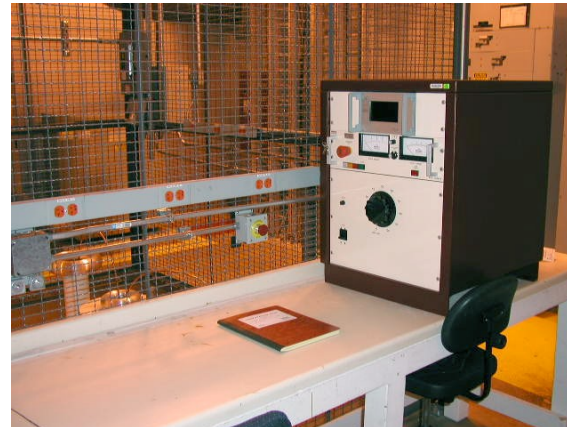
## AC Dielectric Test Set

- Early detection of high-voltage (HV) cable insulation degradation and cable breakdown preventive maintenance.
- Characterization of various HV connector types and selection of those with the highest PD inception voltage and lowest PD current values.
- Testing various greasing and insulating materials and techniques.

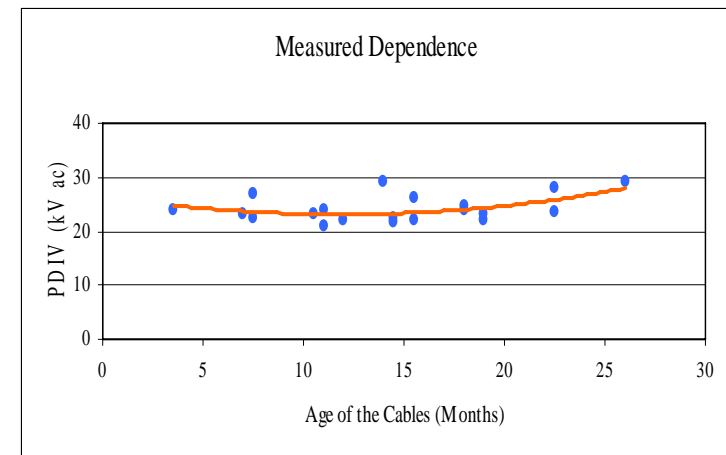
## PDIVs vs. Age of the Modulator Cables

- When we began to perform regular cable PD tests, we expected to see something similar to the plot on the right (not real, just an example!), where each dot would represent PDIV of a cable with a particular age. And if PDIV of any cable falls below some minimal tolerable level, the cable would be immediately replaced ensuring failure preventive maintenance.
- Reality turned to be quite different: no evidence of aging of the insulation in any of the five modulator cables that are regularly tested was observed. What is more, some positive trend may be seen.

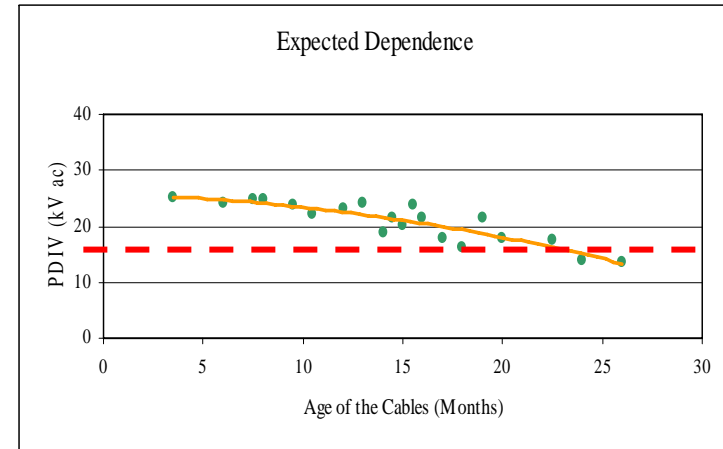
## PDIVs vs. Age of the Modulator Cables

- When we began to perform regular cable PD tests, we expected to see something similar to the plot on the right (not real, just an example!), where each dot would represent PDIV of a cable with a particular age. And if PDIV of any cable falls below some minimal tolerable level, the cable would be immediately replaced ensuring failure preventive maintenance.
- Reality turned to be quite different: no evidence of aging of the insulation in any of the five modulator cables that are regularly tested was observed. What is more, some positive trend may be seen.

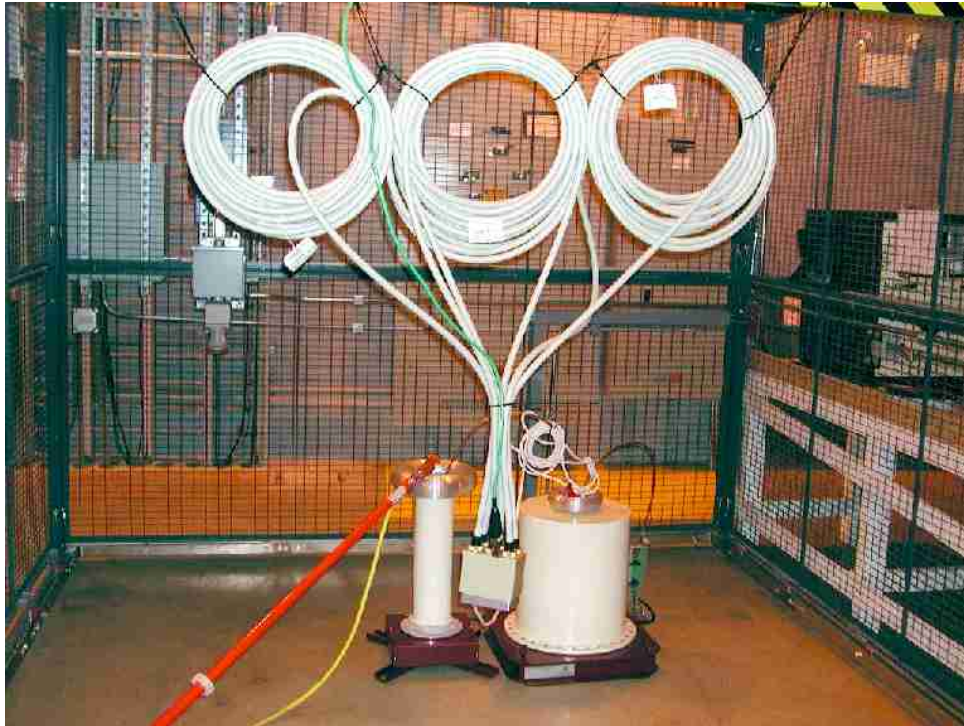
## *Kicker PFN Cable Assembly at the PD Test Set*

- Here is a complete PAR kicker PFN cable assembly ready for testing with the PD test set.

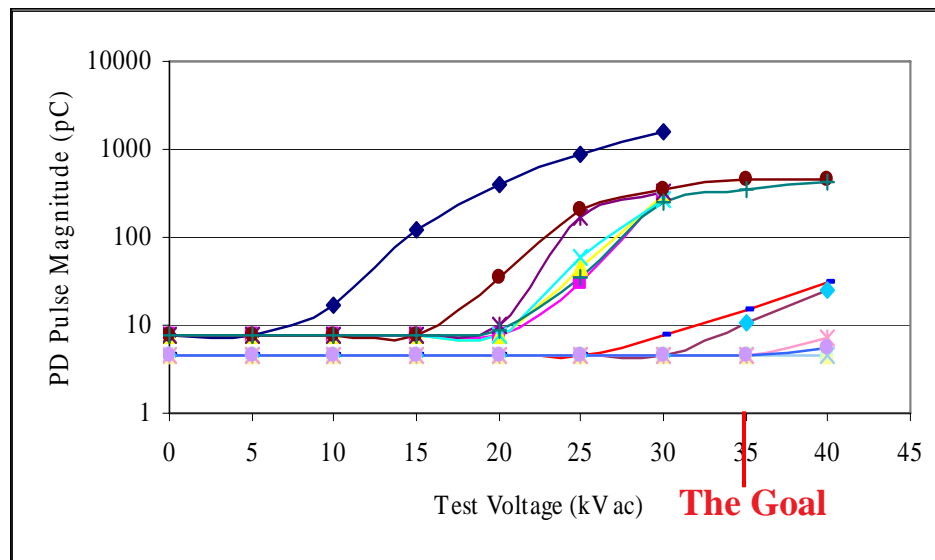
## PAR Kicker Cables – Test Results

- The first prototype cable had a very low PDIV and extremely high magnitude of the PD pulses.
- The next three prototype- and several revised-design cables were better but still far from the design goals.
- Cables that were built after the second revision have shown even greater results, but in order to meet our goals we continued improving the cable termination design and assembly technique.
- The final version of the cable completely meets and even exceeds the design goals, and will be used when new PAR kicker magnets are manufactured.

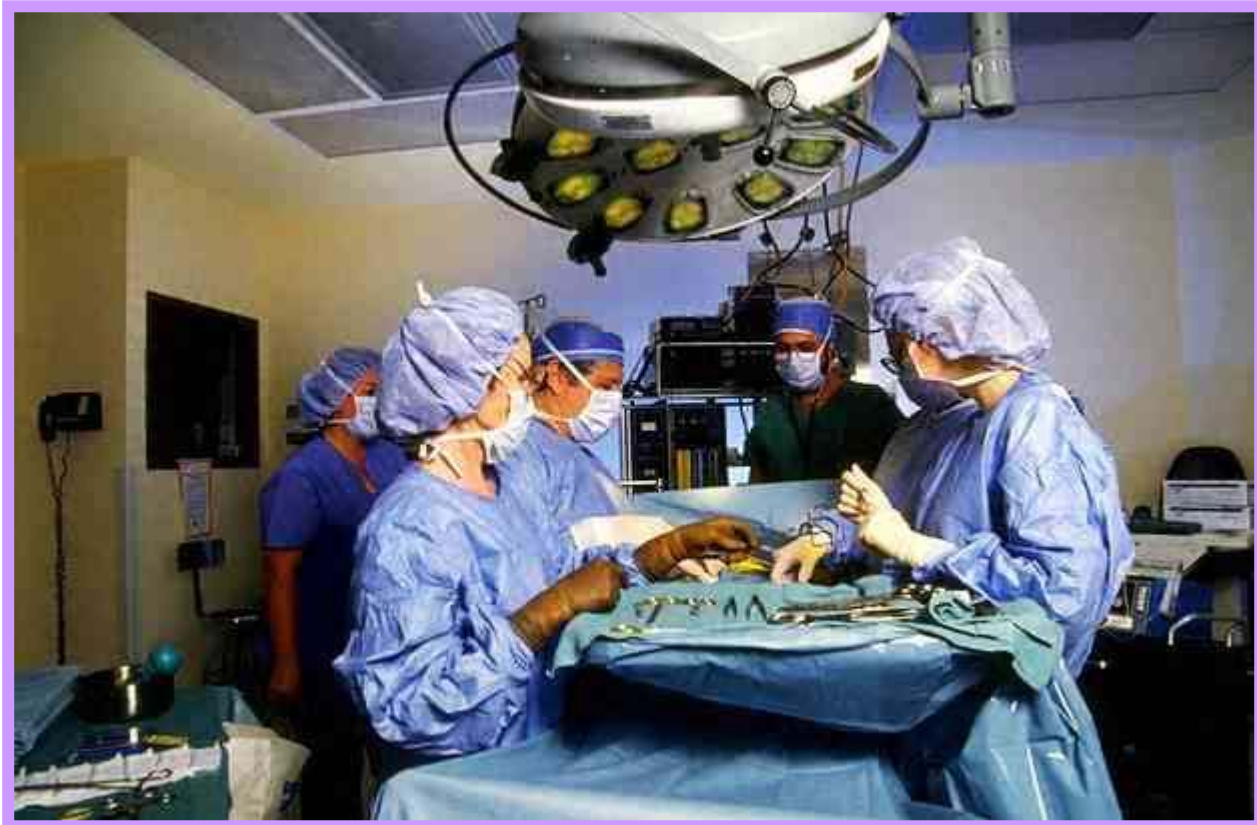
## *Cable Assembly*

- The PAR kicker cable assembly process now looks like this...
