Performance Report on the 20kV/25A Anode Power Supply System Built for the KEK/ANL/ISIS Low output Impedance Collaboration

Doug Horan Advanced Photon Source RF Group

Fourth CW and High Average Power RF Workshop May 1-4, 2006

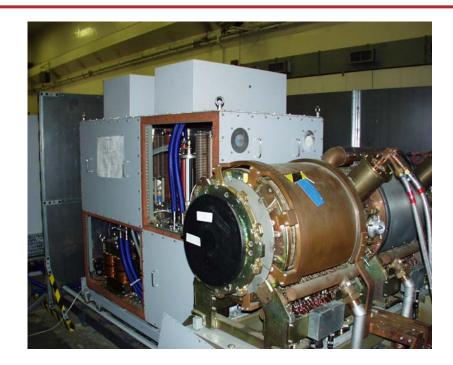
RF amplifier connected to cavity

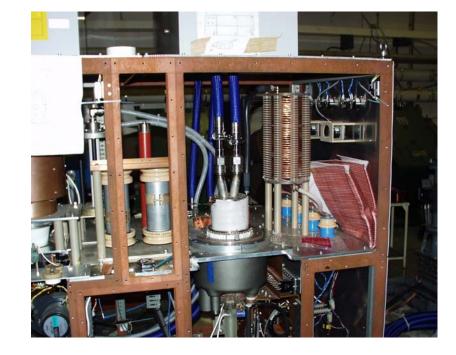
RF amplifier output triode

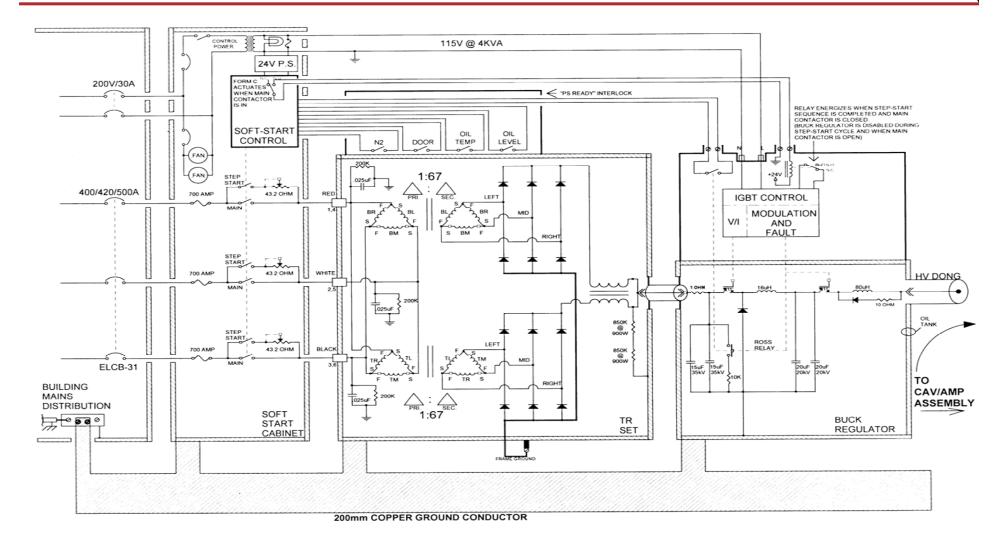
Anode Power Supply System Diagram

The Anode Power Supply consists of the following sub-systems:

- Conventional Transformer-Rectifier Set reconfigured with parallel secondary windings using a twin-choke interphase transformer to achieve 32kV@20A output (*re-used from old ANL rf test stand*)
- Conventional resistor step-start for T-R set 400vac primary
- Diversified Technologies 0-20kV@25A buck regulator with fast HV series IGBT output switch for fault protection

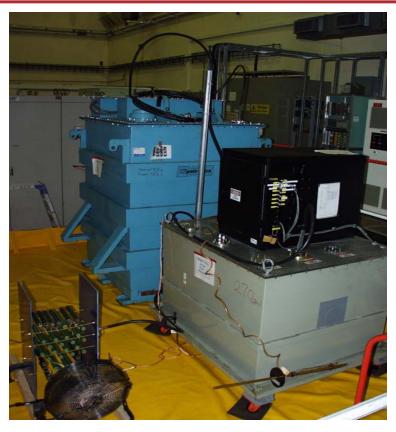
T-R set (blue) and Buck Regulator/Fast Switch tank

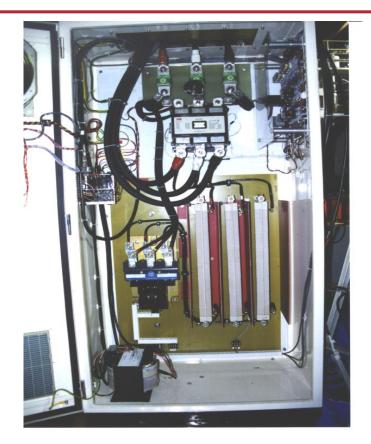
Resistive step-start for T-R set primary input

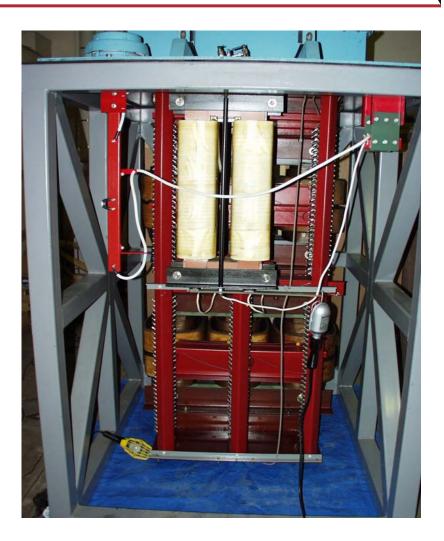
- T-R set interior was visually inspected for any sign of transport damage before being filled with oil (memories of earlier failure in Japan!)
- Photo shows T-R set supported by specially-made inspection stand →
 - -- white coils comprise the twinchoke interphase transformer used to connect the floating secondary windings in parallel

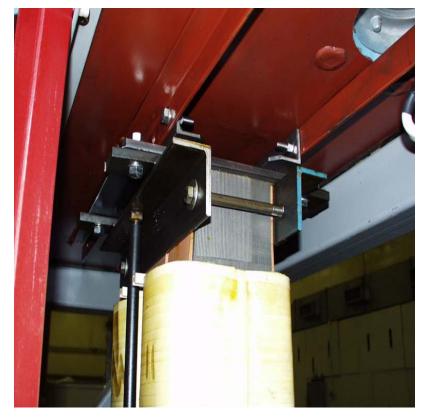
400v primary connections were checked for tightness and evidence of overheating

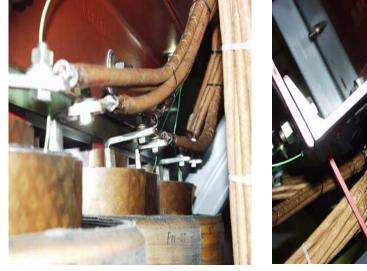
Interphase transformer mounts were checked for tightness

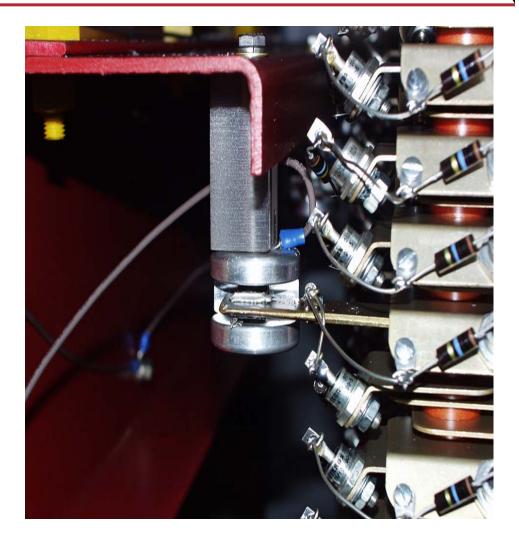
- Only one problem found during the T-R set inspection:
 - → Cold solder joint on rectifier stack

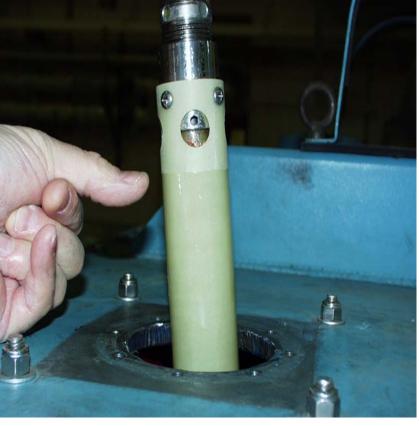
• The T-R set was filled with Midel oil (highflash point), and the oil level was verified as correct on the HV output connector

> <u>Another lesson learned</u> <u>from a previous failure in Japan</u>:

The oil level gauge on the T-R set was not calibrated for correct level when the tank was modified with a different HV output connector.....this caused the connector to arc, resulting in damage to the 400VAC power distribution system

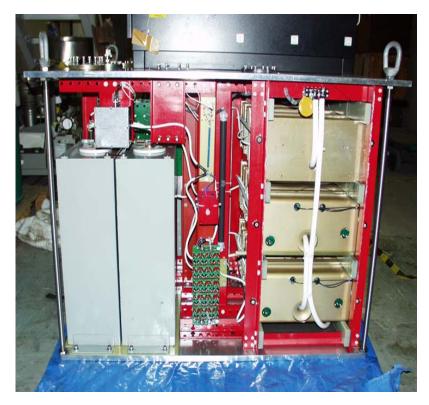
Output capacitors and damping diode

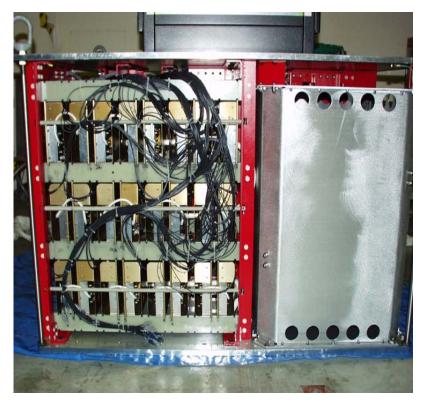
Optical connections to fast series HV output switch modules and output inductor shield

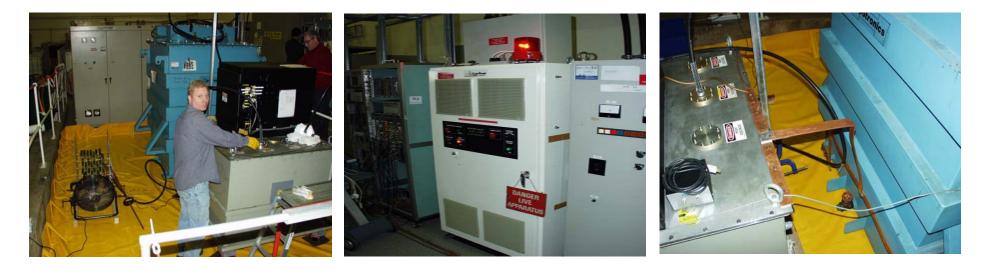
Filling Buck Regulator/Fast Switch tank with Midel oil Installation of step-start in T-R set primary power feed Installation of adequate bonding conductors between sub-systems

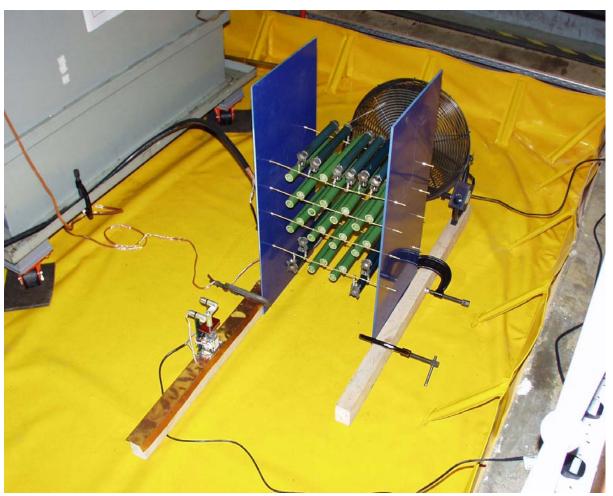
- Low-power resistive load for initial tests of anode power supply
- Included hv relay to test operation of overcurrent interlock at ~ 5kV
- The series IGBT switch opening speed was effective, almost totally eliminating sparking when hv shorting relay was closed with voltage applied – very impressive

- Initial testing was low power into a small resistive load with a shorting relay to verify overcurrent fault operation
 - → HV fault protection very effective due to <1µs response time of the series output switch to a load overcurrent fault
- After fault test, the anode power supply was operated at high power during rf system operation into the cavity <u>in pulsed mode</u>
- The grid bias of the rf output triode was pulsed in and out of cutoff to limit plate dissipation during no-rf periods of the rf voltage function → ANL-designed IGBT grid switcher used for this purpose
- Performance met rf cavity peak voltage specifications
 - → 16kV, peak current 35A@54% duty factor (average current ~ 12.4A)

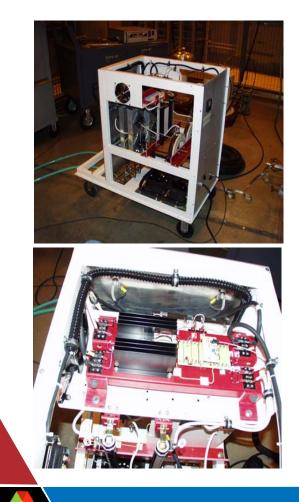
The ANL-designed grid switcher was used to achieve pulsed operation

of the rf amplifier triode

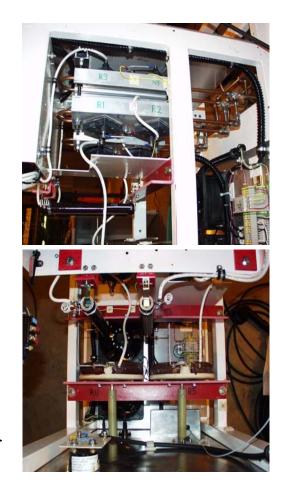
Water-cooled → resistors

← Single IGBT
switched
voltage
divider

Rheostats for field adjustment →

- "Brute-force" design to reduce unknown effects of triode grid current
- Entire IGBT and gating circuit runs only on grid bias voltage supplied by external bias power supply
- Pulsing command optically coupled to IGBT switch
- Rheostats provide field adjustment of bias output ratio

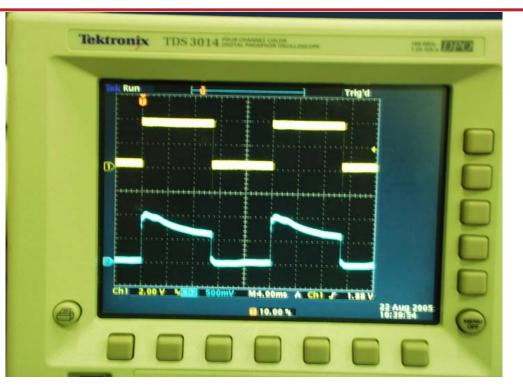
Droop in plate current pulse is due to a 50Hz modulation of rf drive to the triode possibly caused by vibrating filament wires in the Burle 4648 tetrode used to drive the output triode...... *a problem previously noted during system testing in Japan*

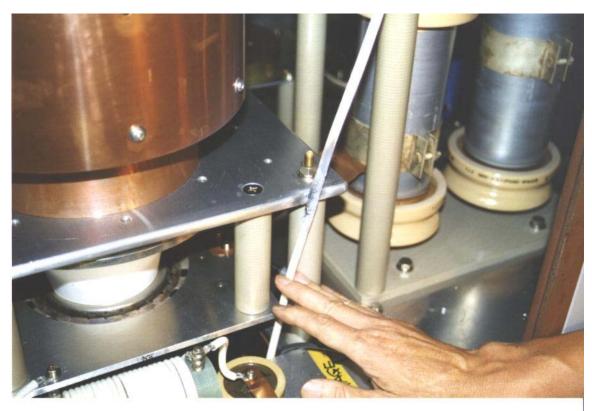
HV wire insulation failure in rf amplifier chassis during early tests →

It made a loud bang, but caused no significant damage!

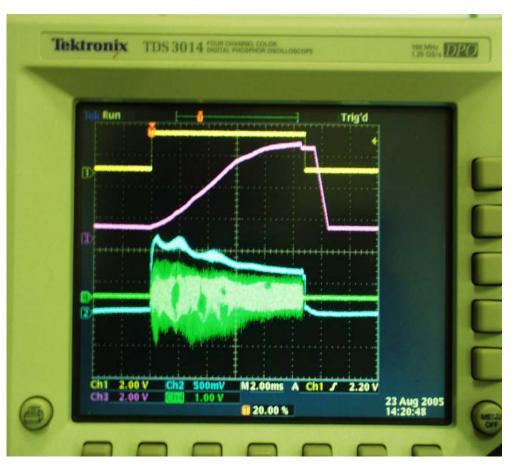
The amount of 10kHz buck regulator switching noise in the power supply output does not appear to be a significant issue in the performance of the LOI rf system

<u>Top wvfm</u>: Grid Switcher gating pulse →

<u>Second wvfm</u>: rf cavity bias current →

<u>Third wvfm</u>: RF amplifier triode plate current →

<u>Fourth wvfm</u>: rf cavity gap voltage →

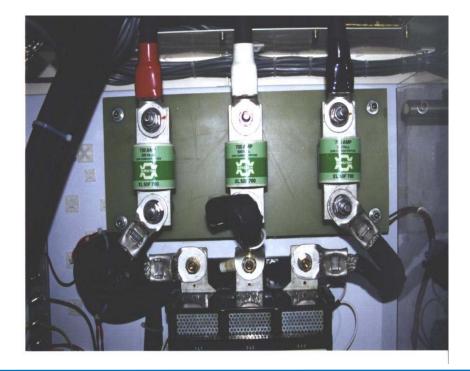
Fuses added to step-start cabinet after the hv connector fault that resulted in destroyed 400V circuit breakers at KEK →

- ALWAYS INCLUDE FUSES ON THE MAINS POWER INPUT IN ANY POWER SUPPLY DESIGN!
 - → DO NOT assume that facility ac power distribution equipment can interrupt the fault current it can deliver!

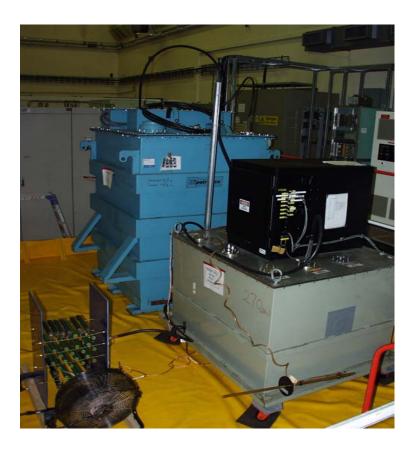
• To reduce costs, the buck regulator was designed to fit into a surplus oil tank that was available.....

But this forced components close together, increasing stray capacitance that increased the coupling of 10kHz buck regulator switching noise in the power supply output than normal
