Status of the ESRF Radio Frequency System

J. Jacob, J.-M. Mercier, P. Barbier

1. ESRF 352 MHz RF system
2. RF operation statistics
3. Experience with 1.3 MW klystrons
4. Waveguide switches
5. Arc detectors
6. New HV deck
7. Cavities

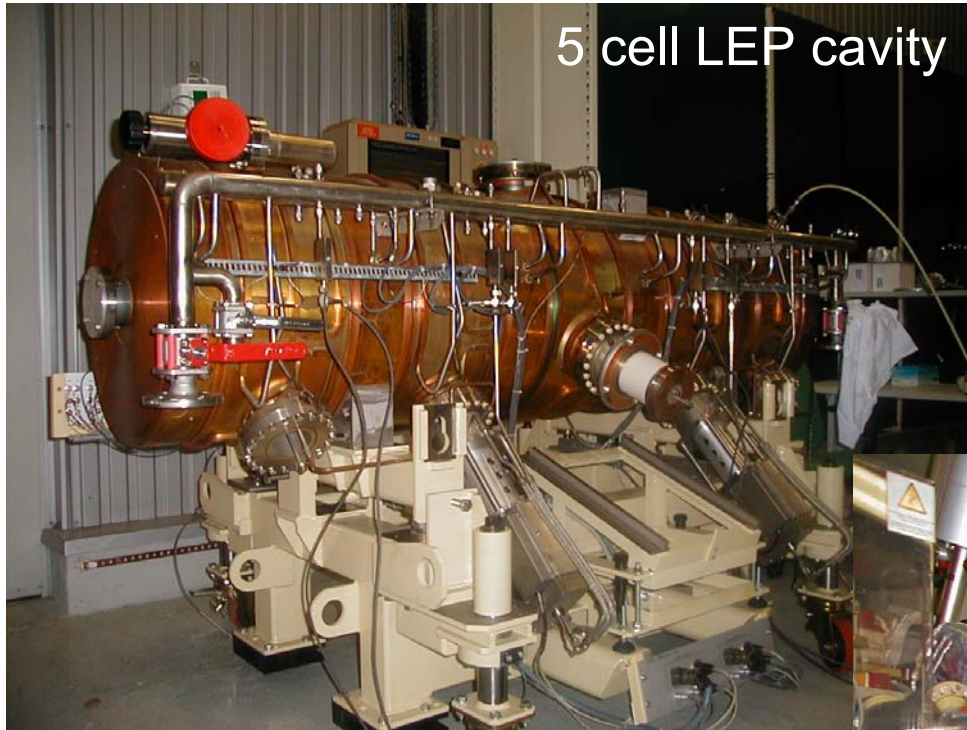
5 cell LEP cavity

- ← 2 LEP cavities (1 coupler) configured to replace ESRF cavities in the booster (goal: more spares for SR)
- ← 1st LEP cavity already reached required 4 MV in pulsed mode on the RF power teststand

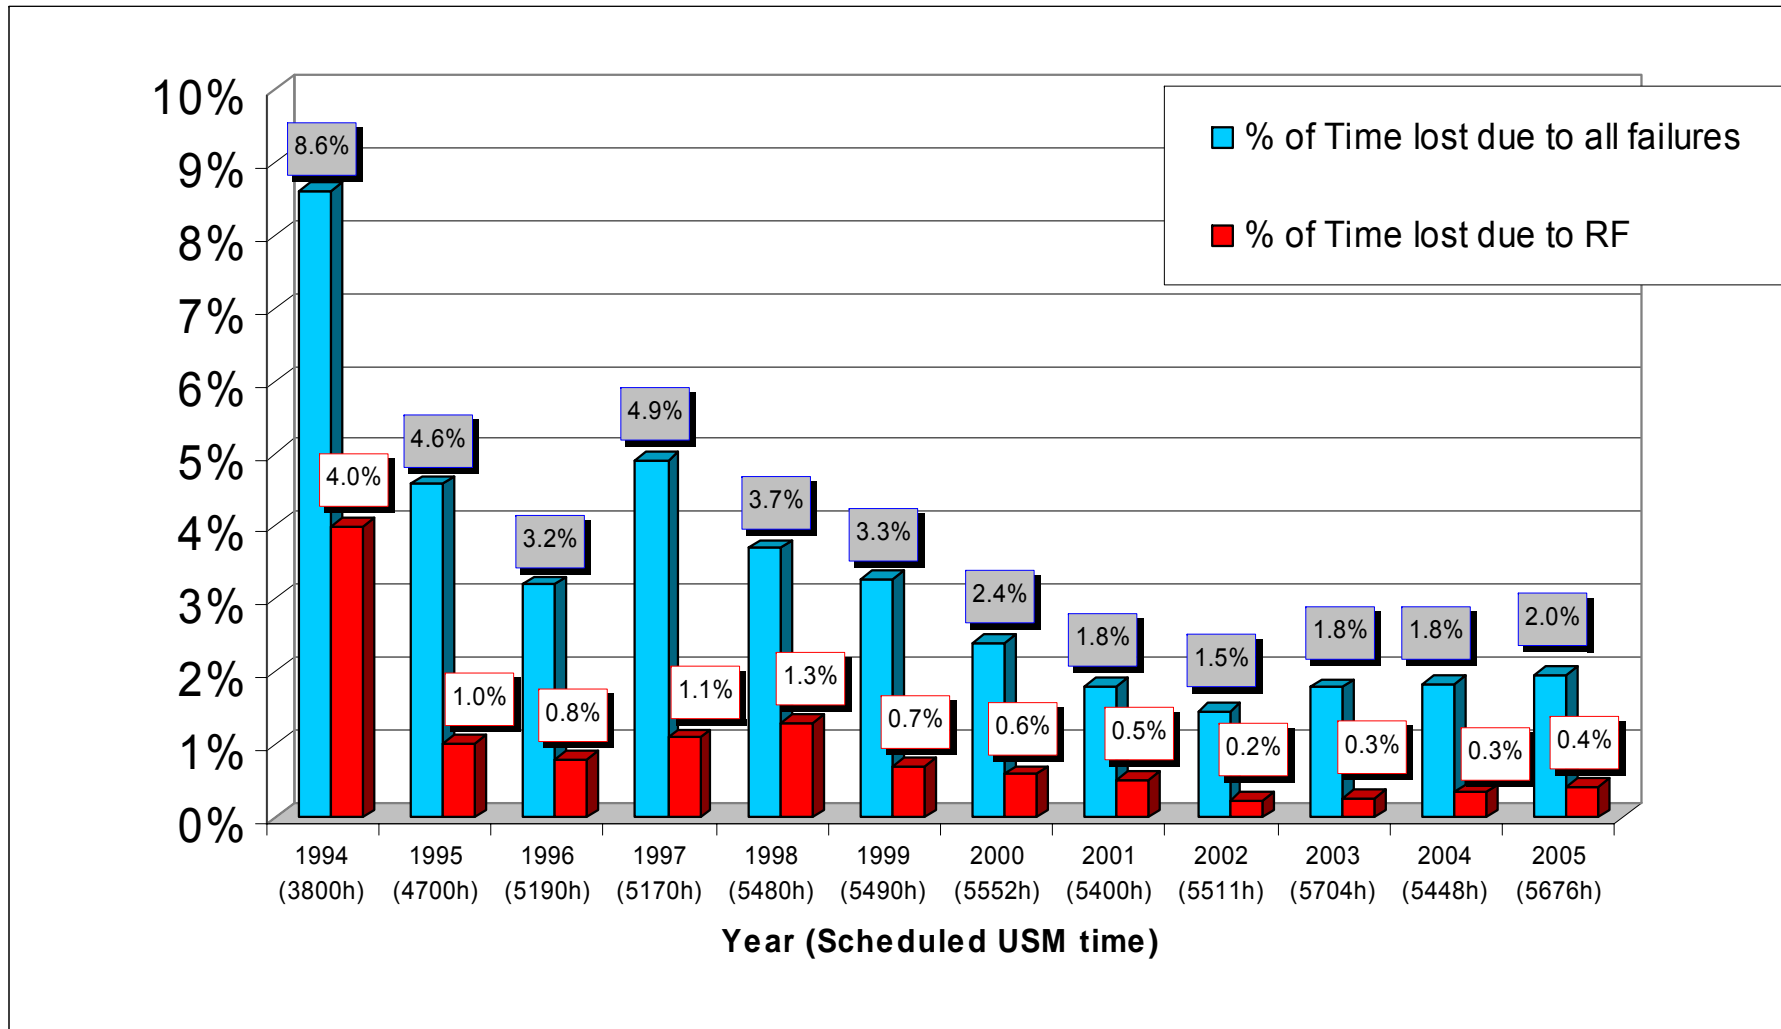
Example 2005

44 RF trips in 2005 (32 in 2004)

- **RF low level: 11 trips**
 - 9 trips due one bad cable connector
- **Klystron auxiliaries: 9 trips**
 - 3 trips: mod. anode PS
 - 2 trips: Ion pump PS (replaced by new type)
 - 4 trips: Focusing PS (replaced Interlockelectronics)
- **Arcs: 8 trips**
 - 5 real arcs on Tee0 ⇒ then replaced
 - 3 on circulators (no damage)
- **Klystrons: 5 trips**
 - 2 gun break downs (SRRF1)
 - 1 Outgassing (SRRF1)
 - 1 Sideband (SRRF2)
 - 1 Overdrive (SYRF)
- **Cavity 5: 3 trips**
 - 3 breakdowns
 - RF reconditioned, stop Ti-Sublimation: no conclusion on impact yet
- **8 other trips:**
 - Essentially understood and corrective actions taken

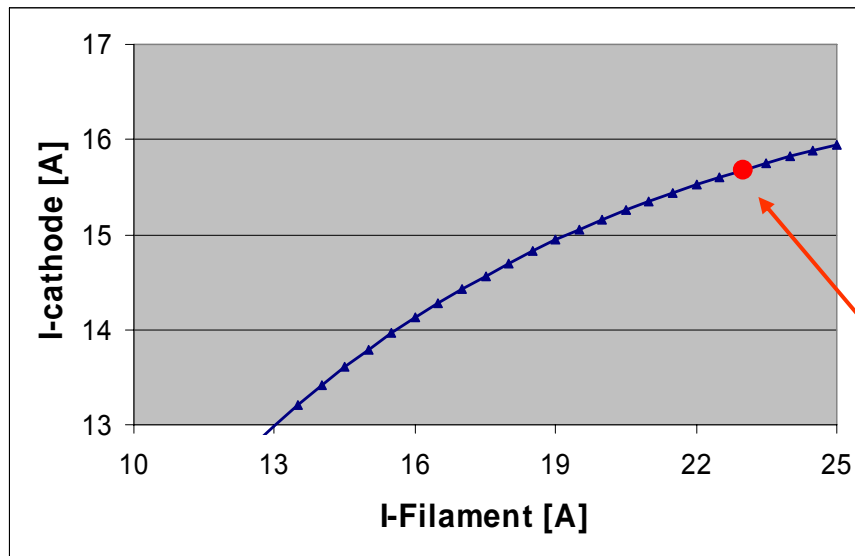
Heating curves:

- Every 6000 h or once/year
- Working point optimized for nominal ($V_{cathode}$, $I_{cathode}$) settings

$$\text{Criterion : } \frac{I_{cathode}}{I_{filament}} \approx 0.15$$

- $I_{filament}$ too low \Rightarrow field emission \Rightarrow bad for cathode lifetime
- $I_{filament}$ too high \Rightarrow Barium evaporation \Rightarrow I_{anode} , Breakdowns

2. Low heating: $I_{filament}$ reduced by 30 % \Rightarrow systematically for HV OFF
3. Monitor Anode current (< 1 to 1.5 mA)

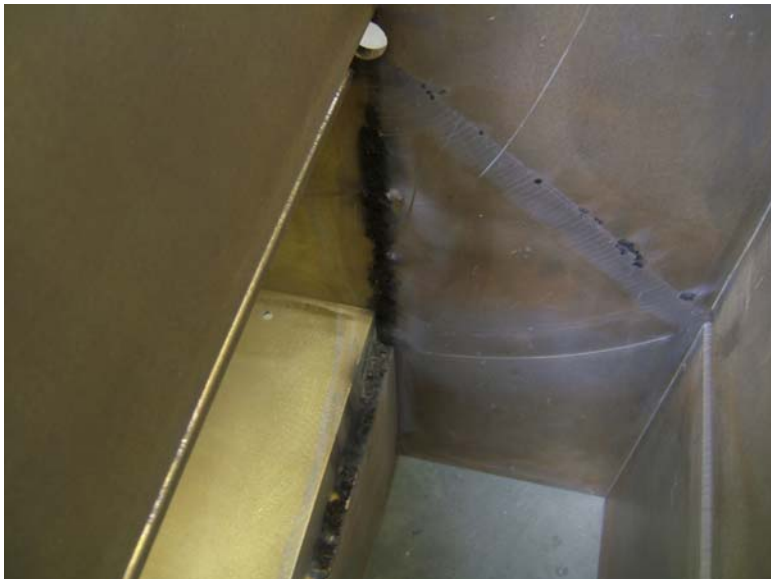
4. Waveguide switches

- **Already**
 - 3 waveguide switches destroyed
 - 15 installed / 2 good spares left
- **Mechanical problems:**
 - RF fingers
 - Flap position
 - Limit switch adjustment
- **Experience ⇒**
 - Arc detectors not too far (maximum at 1 bend, 2 to 3 m distance)
 - Several arcs ⇒ immediate verification and maybe exchange
 - Regular check
 - 1st Mechanical adjustment, incl. axis excentricity
 - 2nd Check RF isolation ≥ 80 dB
