Module 6 Clean-up

July 2005

Module 6 History

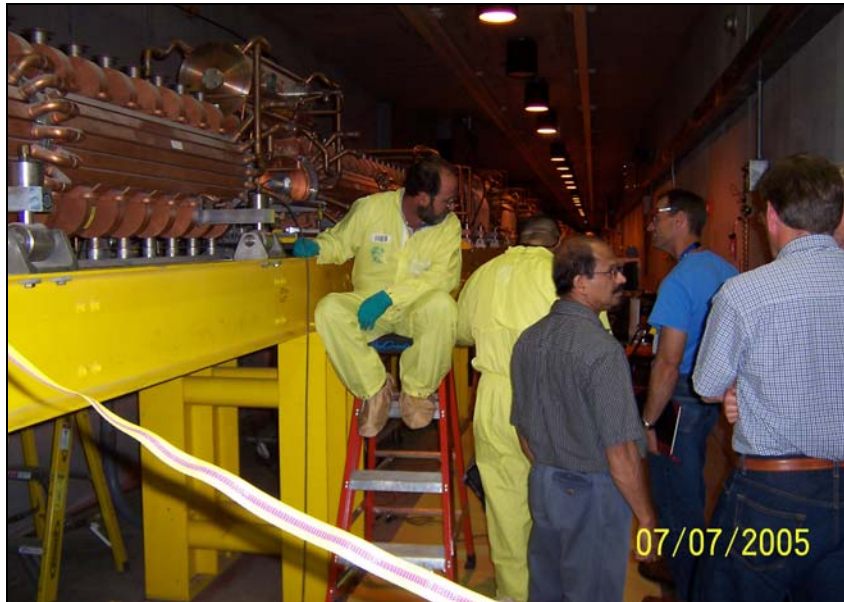
Initial inspection with the Bore-scope.

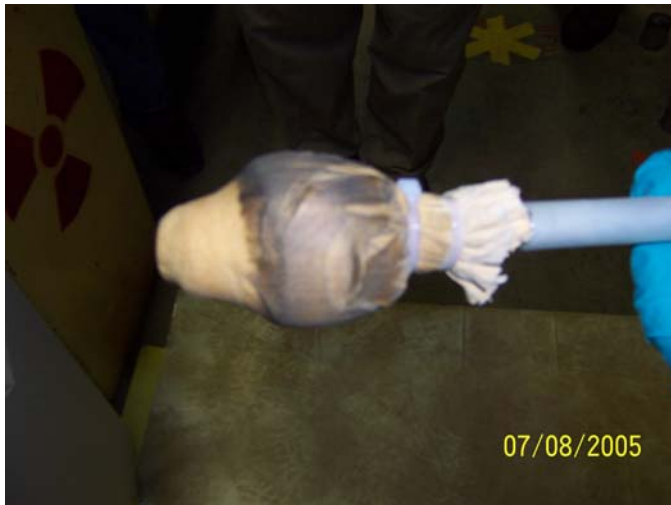
Q tip cleaning tool after
the initial cleaning

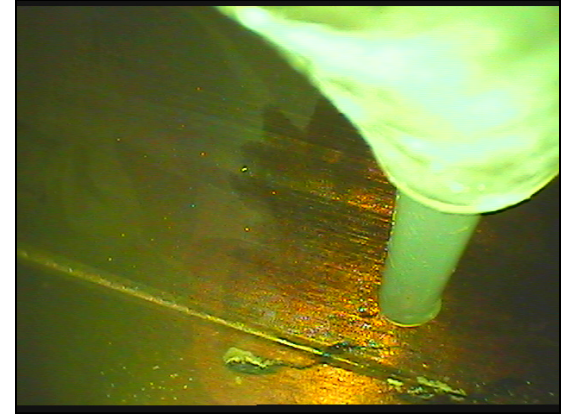
Tygon tubing with poly-flow working tool working at the bottom of cell #8

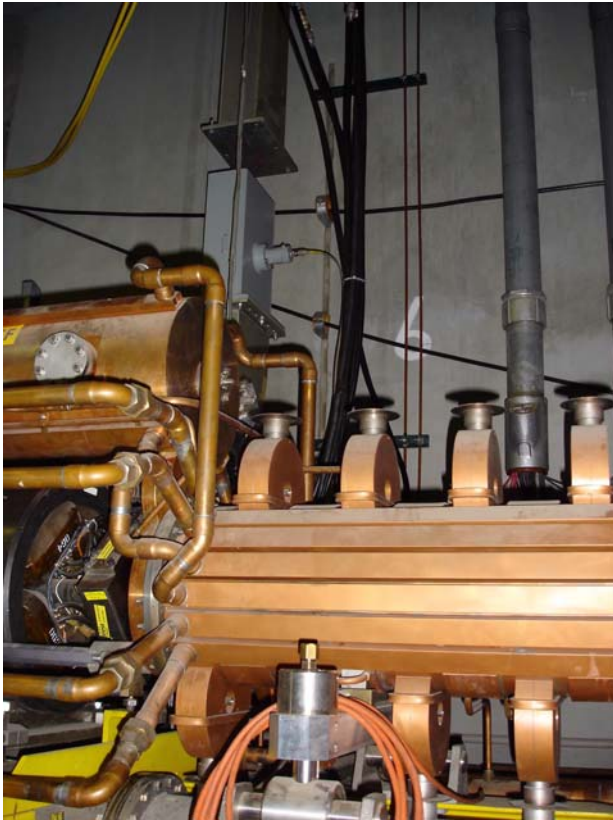
Drive through type N transition on waveguide

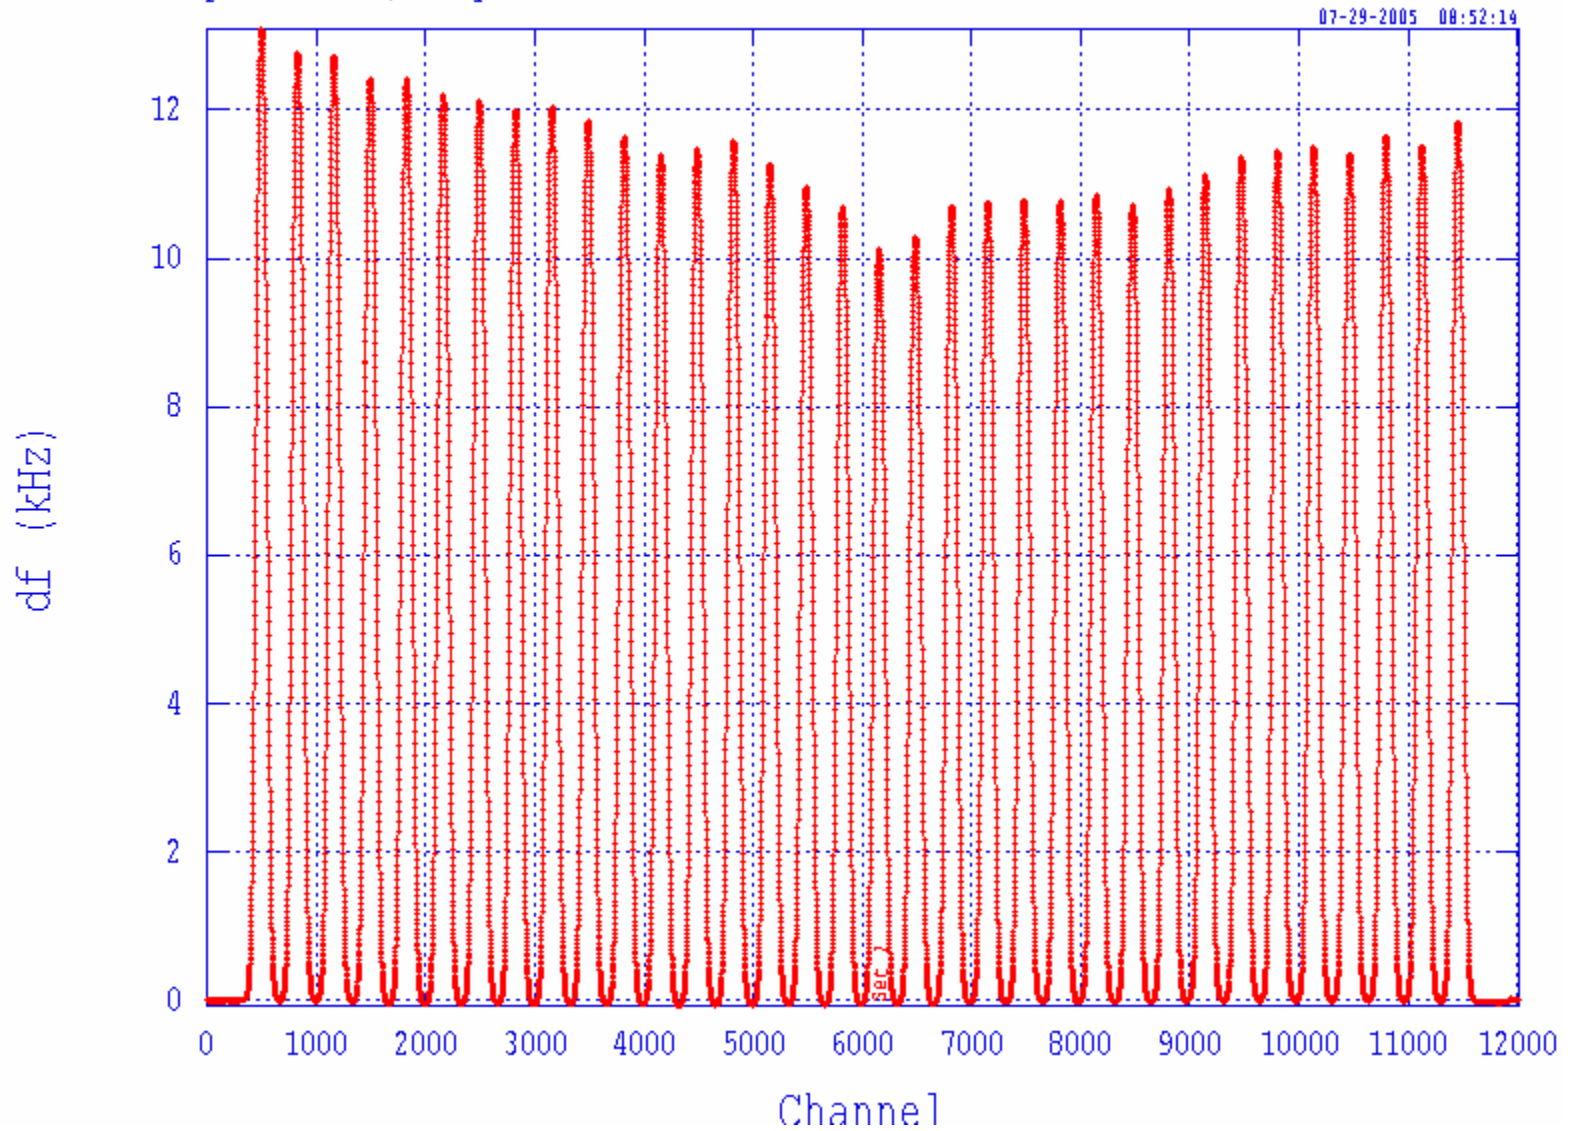
Bead Pull Results – Frequency Shift

Beadpull data, Sequence number 006

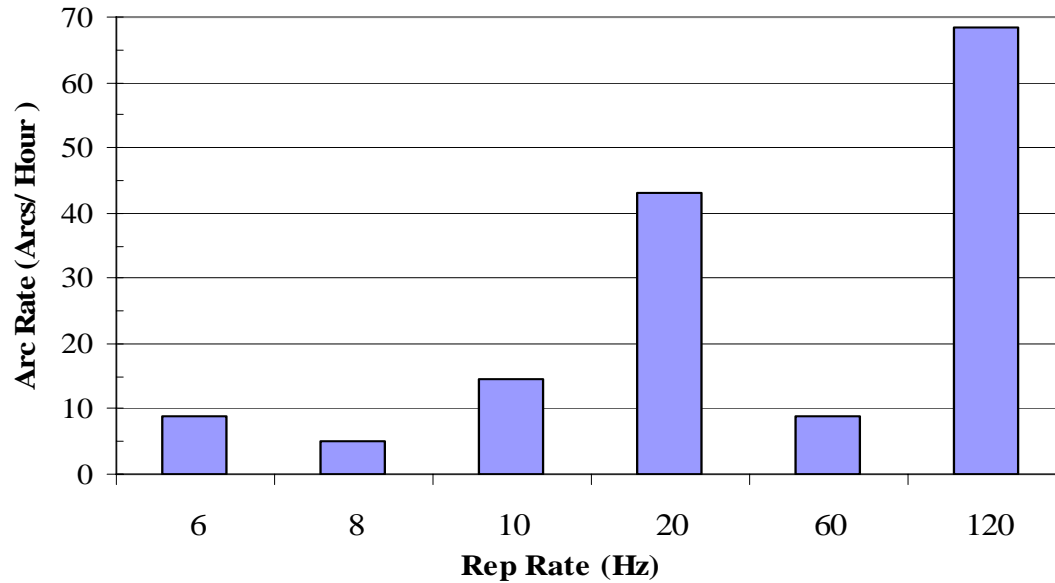
Pre Cleaning Arc Rate

- The arc rate per hour listed is the maximum arc rate recorded.

- The O-ring had been burnt into the surface which led to debris in the vacuum. The high VSWR before the cleaning was probably caused from the O-ring debris in vacuum system, especially in the high field region.

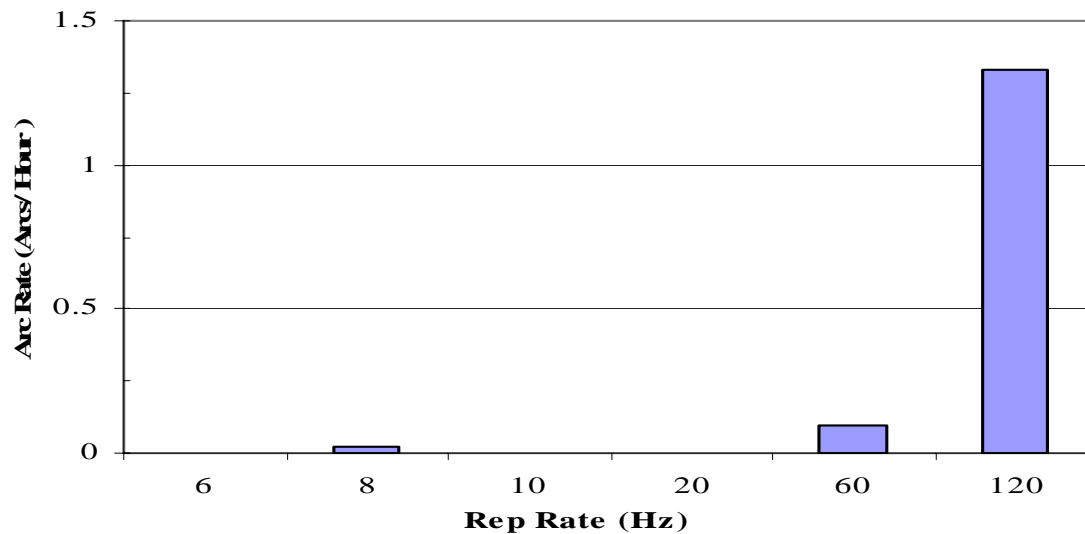
Post Cleaning Arc Rate

- Limited data has been taken since the cleaning.

- The cleaning reduced the number of VSWRs significantly. Hopefully as the module is conditioned this number will still decrease. Even after the cleaning Module 6 VSWRs way more than a healthy module.
